1. TITLE (Class, Function, Type, etc.)		2. DOCUMENT NUMBER
Leak Test Failure on MIL-DTL-38999, Series III Connectors		NX4-P-16-01A
		3. DATE (DD-MMM-YY)
		01-APR-16
4. MANUFACTURER AND ADDRESS	5. PART NUMBER	6. NATIONAL STOCK NUMBER
Amphenol Aerospace Operations	M38999	Not Available
40-60 Delaware Ave	7. SPECIFICATION	8. GOVERNMENT PART NUMBER
Sidney, NY 13838-1304	MIL-DTL-38999	M38999
	9. LOT DATE CODE START	10. LOT DATE CODE END
	1201	1352
11. MANUFACTURER'S POINT OF CONTACT	12. CAGE	13. MANUFACTURER'S FAX
Ron Williams	77820	Not Available
14. MFR. POC PHONE	15. MANUFACTURER'S E-MAIL	
(607) 563-5344	rwilliams@amphenol-aao.com	
16. SUPPLIER - Not Applicable	17. SUPPLIER ADDRESS - Not Applicable	18. SUPPLIER CAGE - Not Applicable

19. PROBLEM DESCRIPTION / DISCUSSION / EFFECT
 Amendment A has been issued to remove references to photos that were not included in the original document.

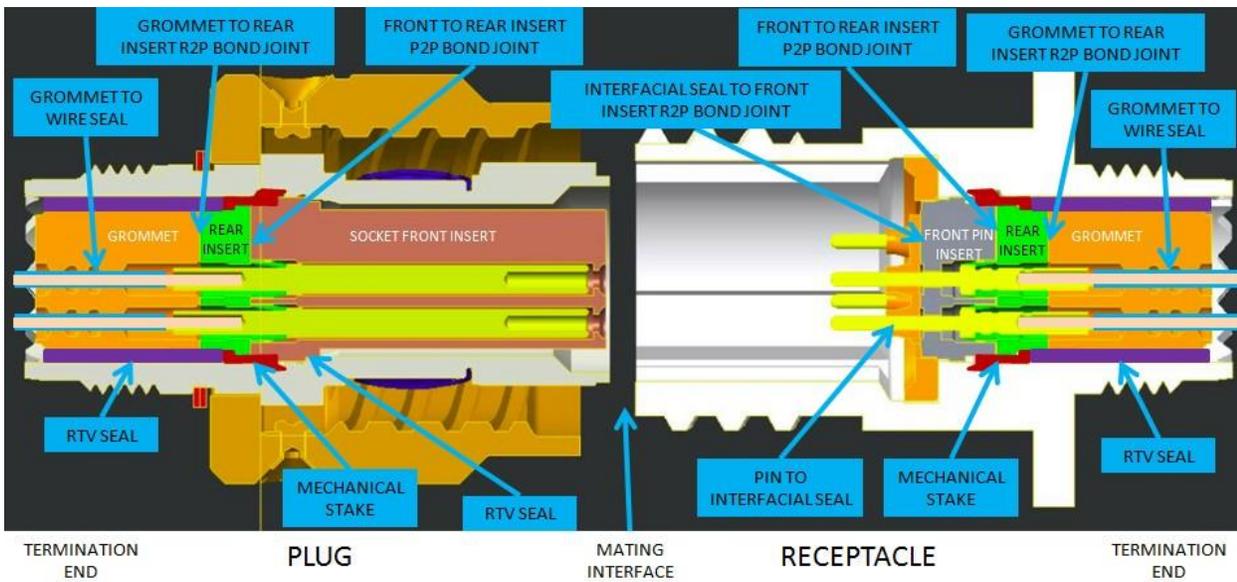
From the termination end of a connector, the interior of the contact cavities are protected by 3 sealing webs in each contact cavity of the rear silicone grommet. As long as the minimum diameter specified by the MIL-DTL-38999 spec is met by the wire, PC tail, and/or the sealing plug, there will be no leakage path. In addition, an RTV sealant is applied between the grommet and the inside of the shell.

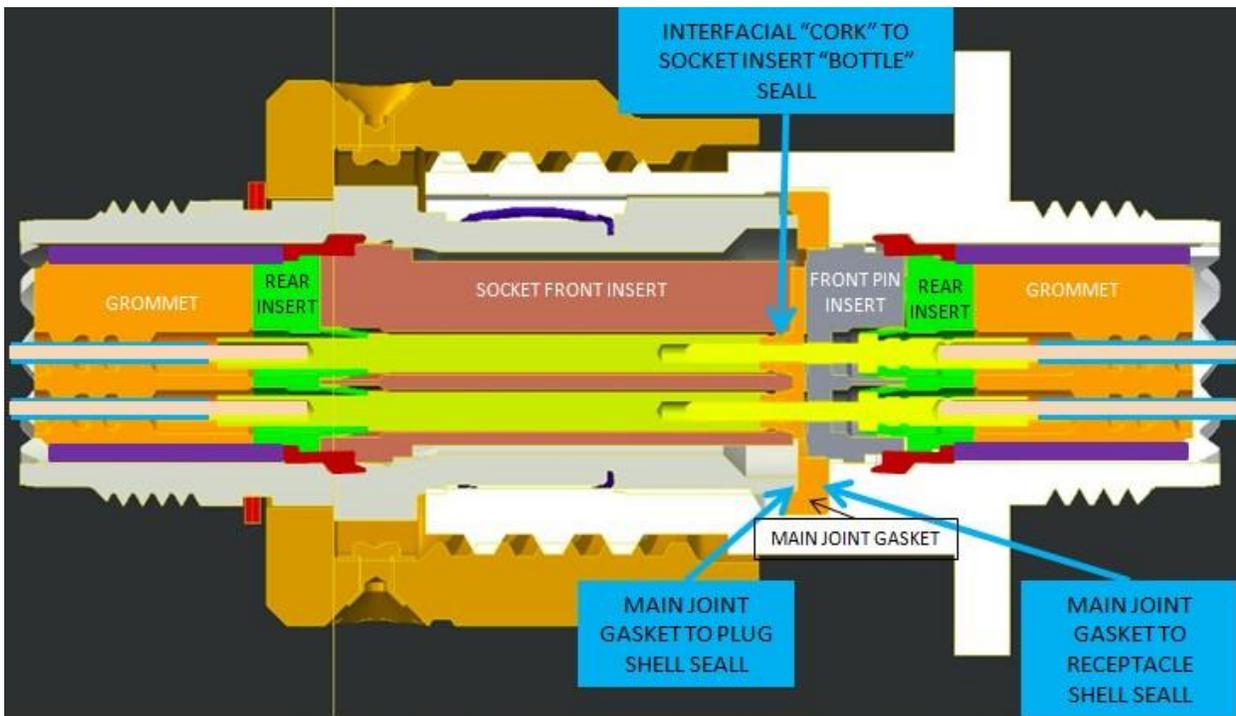
PLUG MATED TO THE RECEPTACLE

In the mated condition, there are two sealing elements that engage to further protect the individual contact cavities. First is the main joint gasket, which is compressed between the plug and receptacle shells. In parallel to the main joint gasket, the towers on the interfacial seal on the pin side seal into the rigid chamfered main interface of the socket insert, creating a “cork and bottle” seal.
