MIL-DTL-83723 Retention Testing

NX4-P-16-07

Amphenol Aerospace  
40-60 Delaware Ave  
Sidney, NY 13838

MIL-DTL-83723

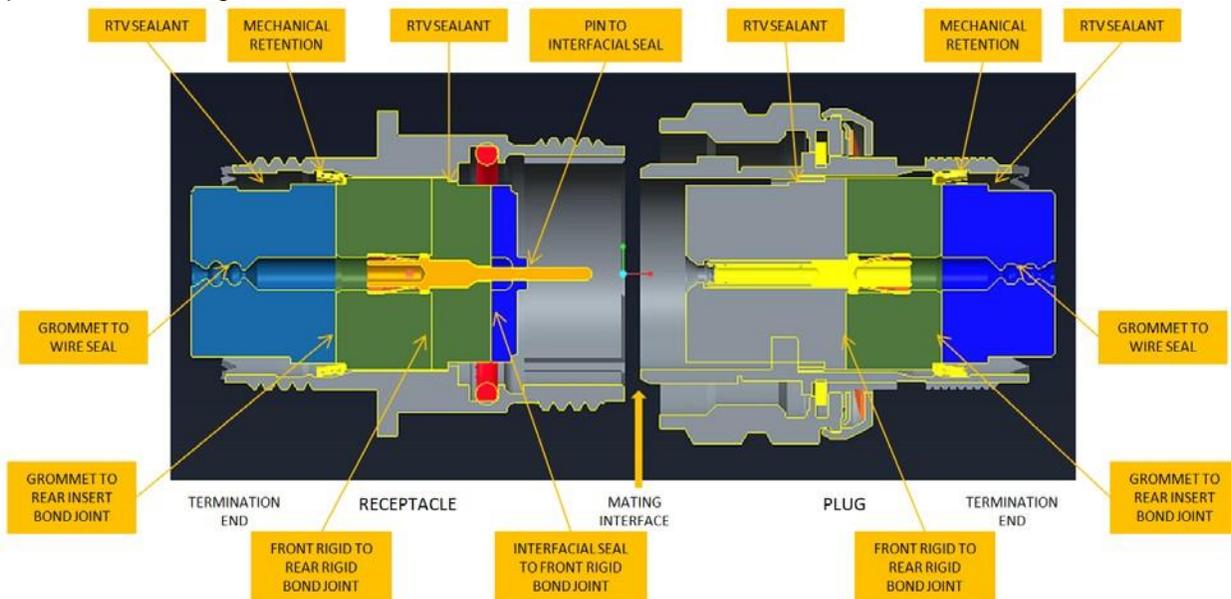
From the termination end of a connector, the interior of the contact cavities are protected by 3 sealing webs in each contact cavity of the rear silicone grommet. As long as the minimum diameter specified by the MIL-DTL-83723 spec is met by the wire, PC tail, and/or the sealing plug, there will be no leakage path. In addition, an RTV sealant is applied between the grommet and the inside of the shell.

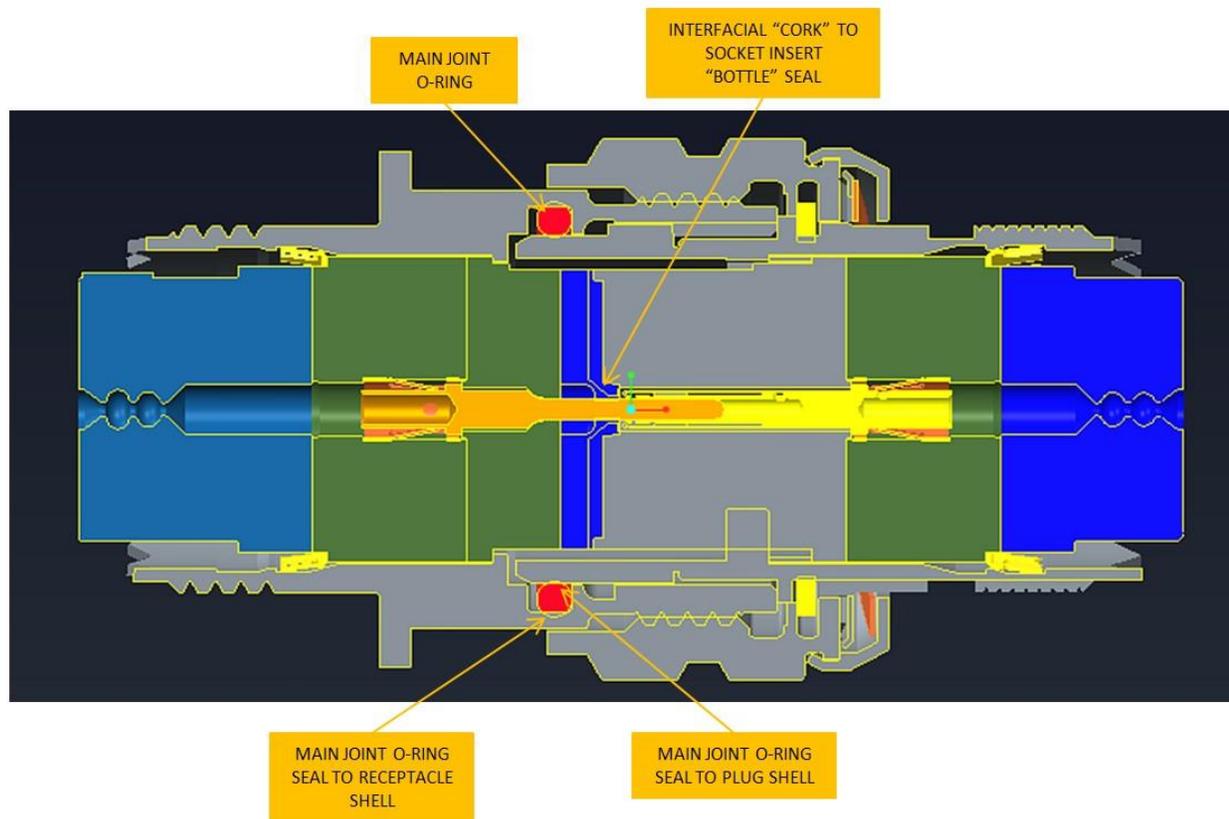
In the mated condition, there are two sealing elements that engage to further protect the individual contact cavities. First is the main joint o-ring seal, which is compressed between the outside diameter of the plug and inside diameter of the receptacle shells. In parallel to the main joint o-ring seal, the towers on the interfacial seal on the pin side seal into the rigid chamfered main interface of the socket insert, creating a “cork and bottle” seal.
