NAPL PLUME STUDY

FINAL REPORT

**For
Defense Personnel Support Center
Philadelphia, Pennsylvania**

USACE Contract No. DACA31-94-D-0017

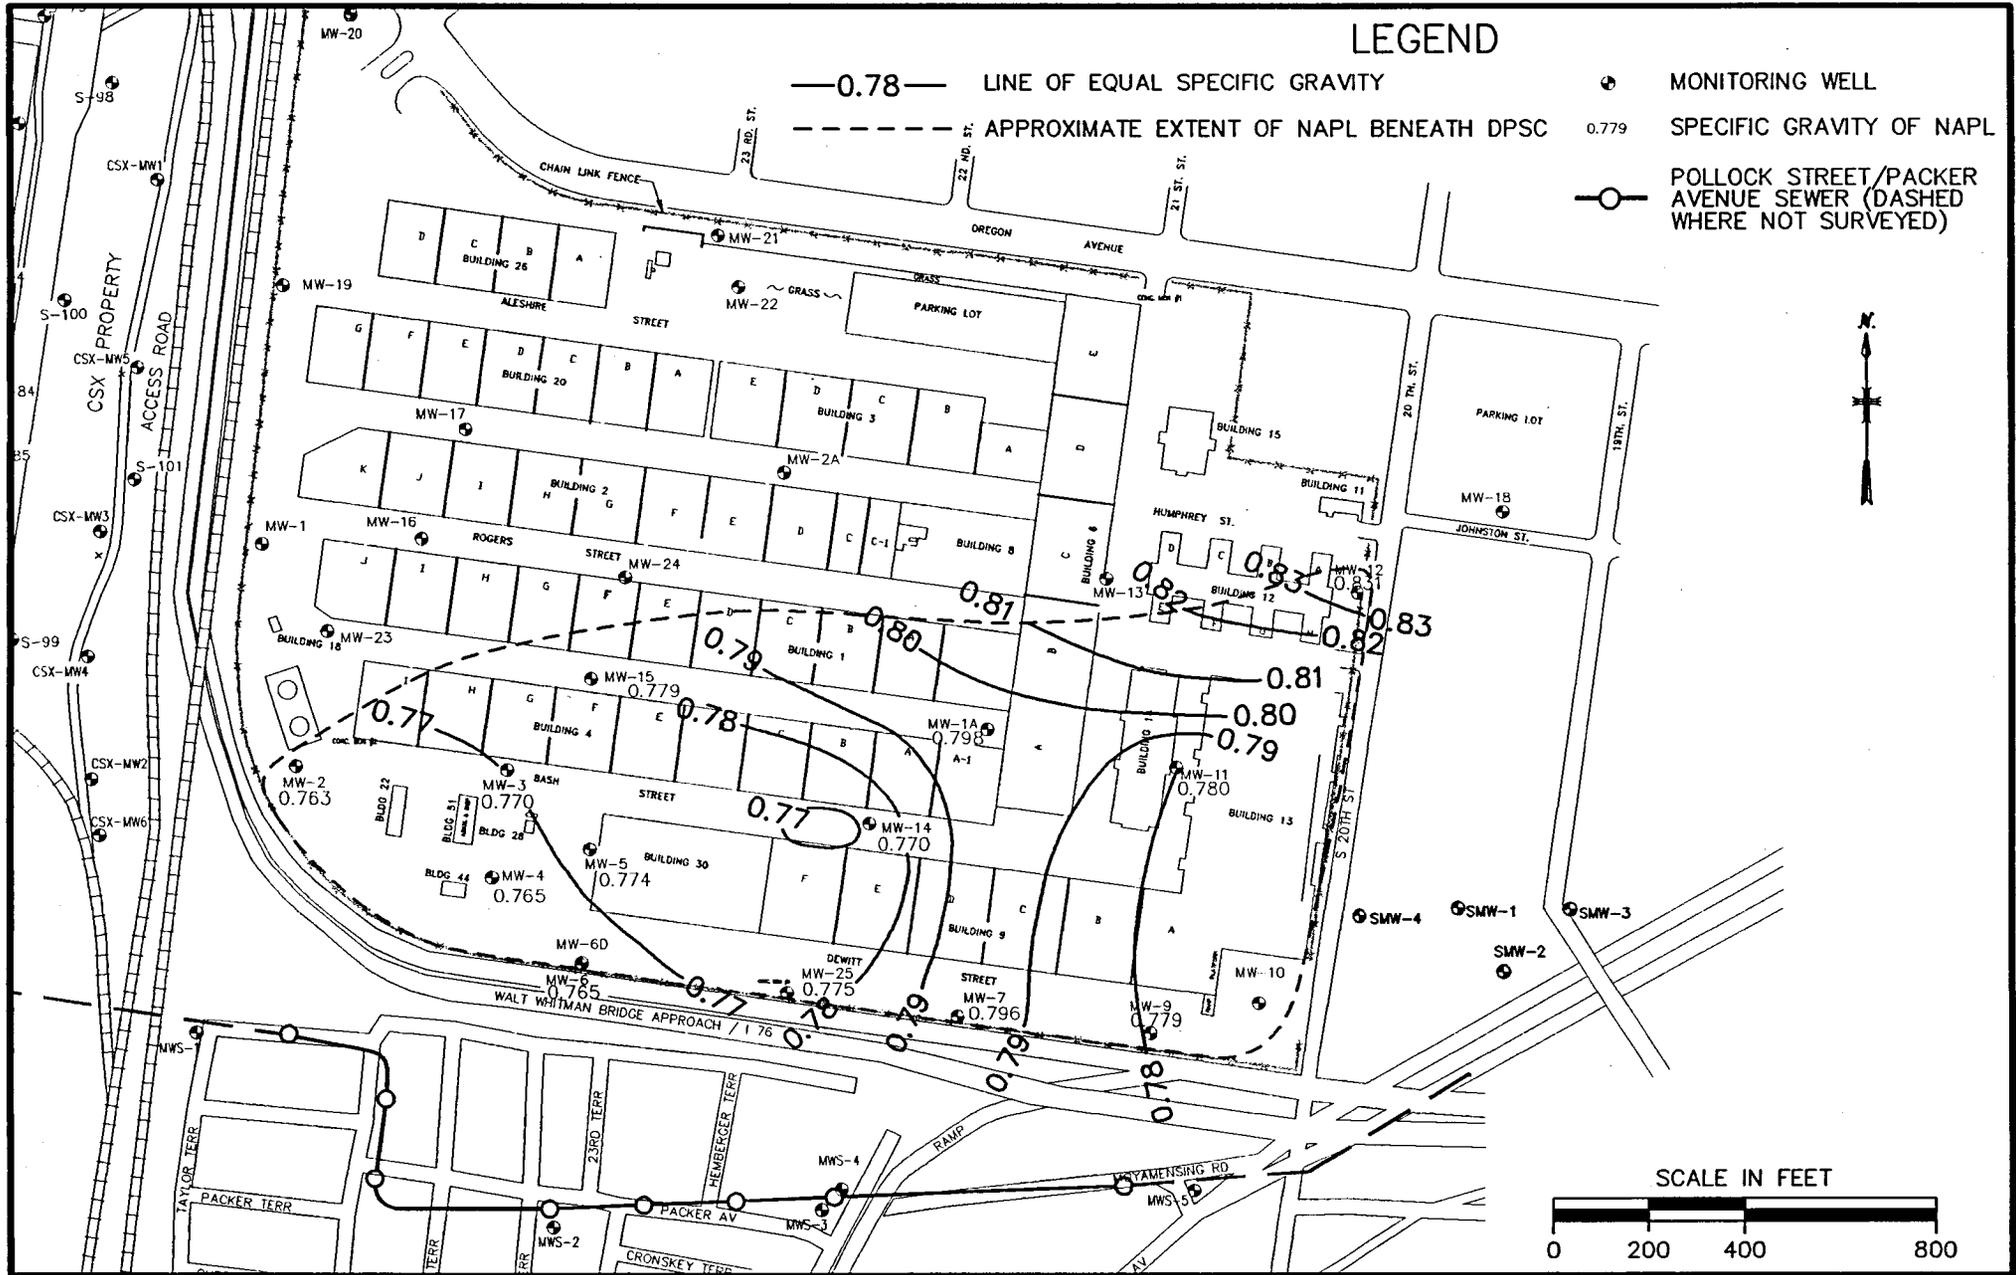
- MONITORING WELL
- 0.779 SPECIFIC GRAVITY OF NAPL
- POLLOCK STREET/PACKER AVENUE SEWER (DASHED WHERE NOT SURVEYED)

DEFENSE PERSONNEL SUPPORT CENTER
 USACE CONTRACT NO. DACA31-94-D-0017
 NAPL SPECIFIC GRAVITY CONTOURS

Laboratory analyses of NAPL samples collected at DPSC identified a pattern of relatively undegraded, new NAPL in the western portion of DPSC and relatively degraded, old NAPL in the eastern portion of DPSC. The distribution of *n*-alkanes in NAPL and soil samples, and site-wide differences in the specific gravities of NAPL samples (Figure ES-4), indicate that the NAPL plume migrated onto DPSC from the ARCO/Sun Refinery property, an off-site source to the west-northwest of DPSC.

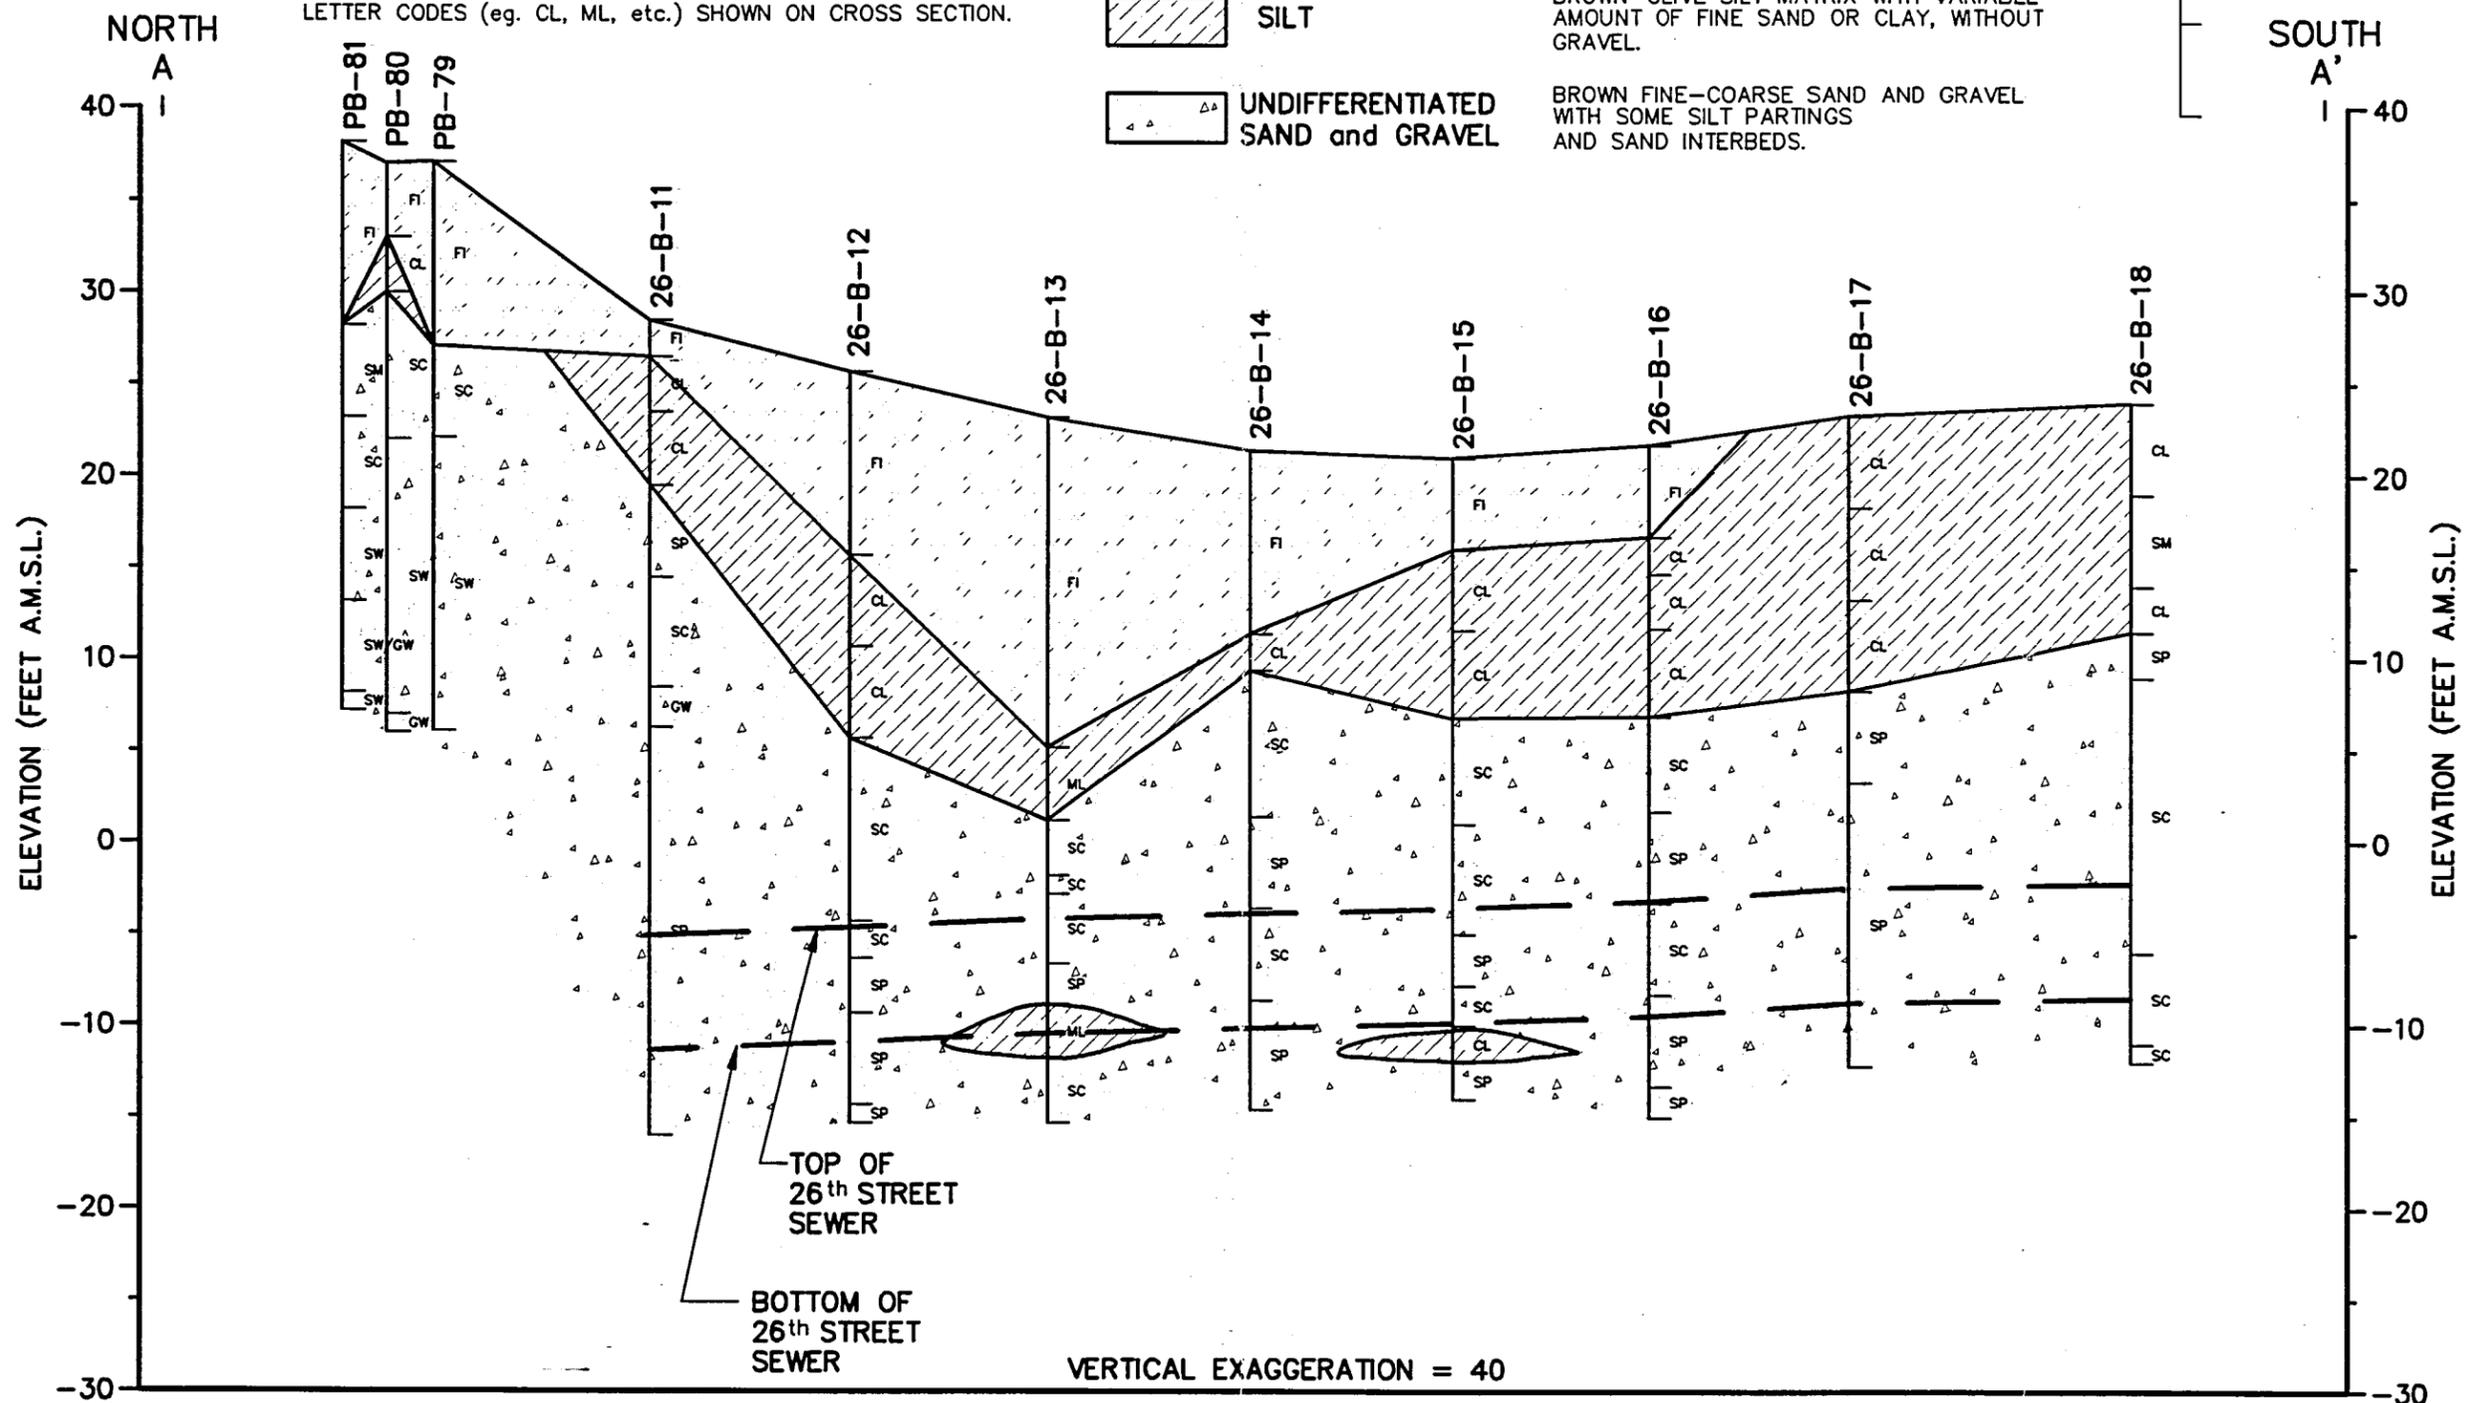
CROSS-SECTION A-A'

BROWN-GRAY SILT AND/OR CLAY BACKFILL WITH VARIABLE AMOUNTS OF CONSTRUCTION AND BURN DEBRIS WITH SLAG AND COAL ASH.

BROWN FINE-COARSE SAND AND GRAVEL WITH SOME SILT PARTINGS AND SAND INTERBEDS.

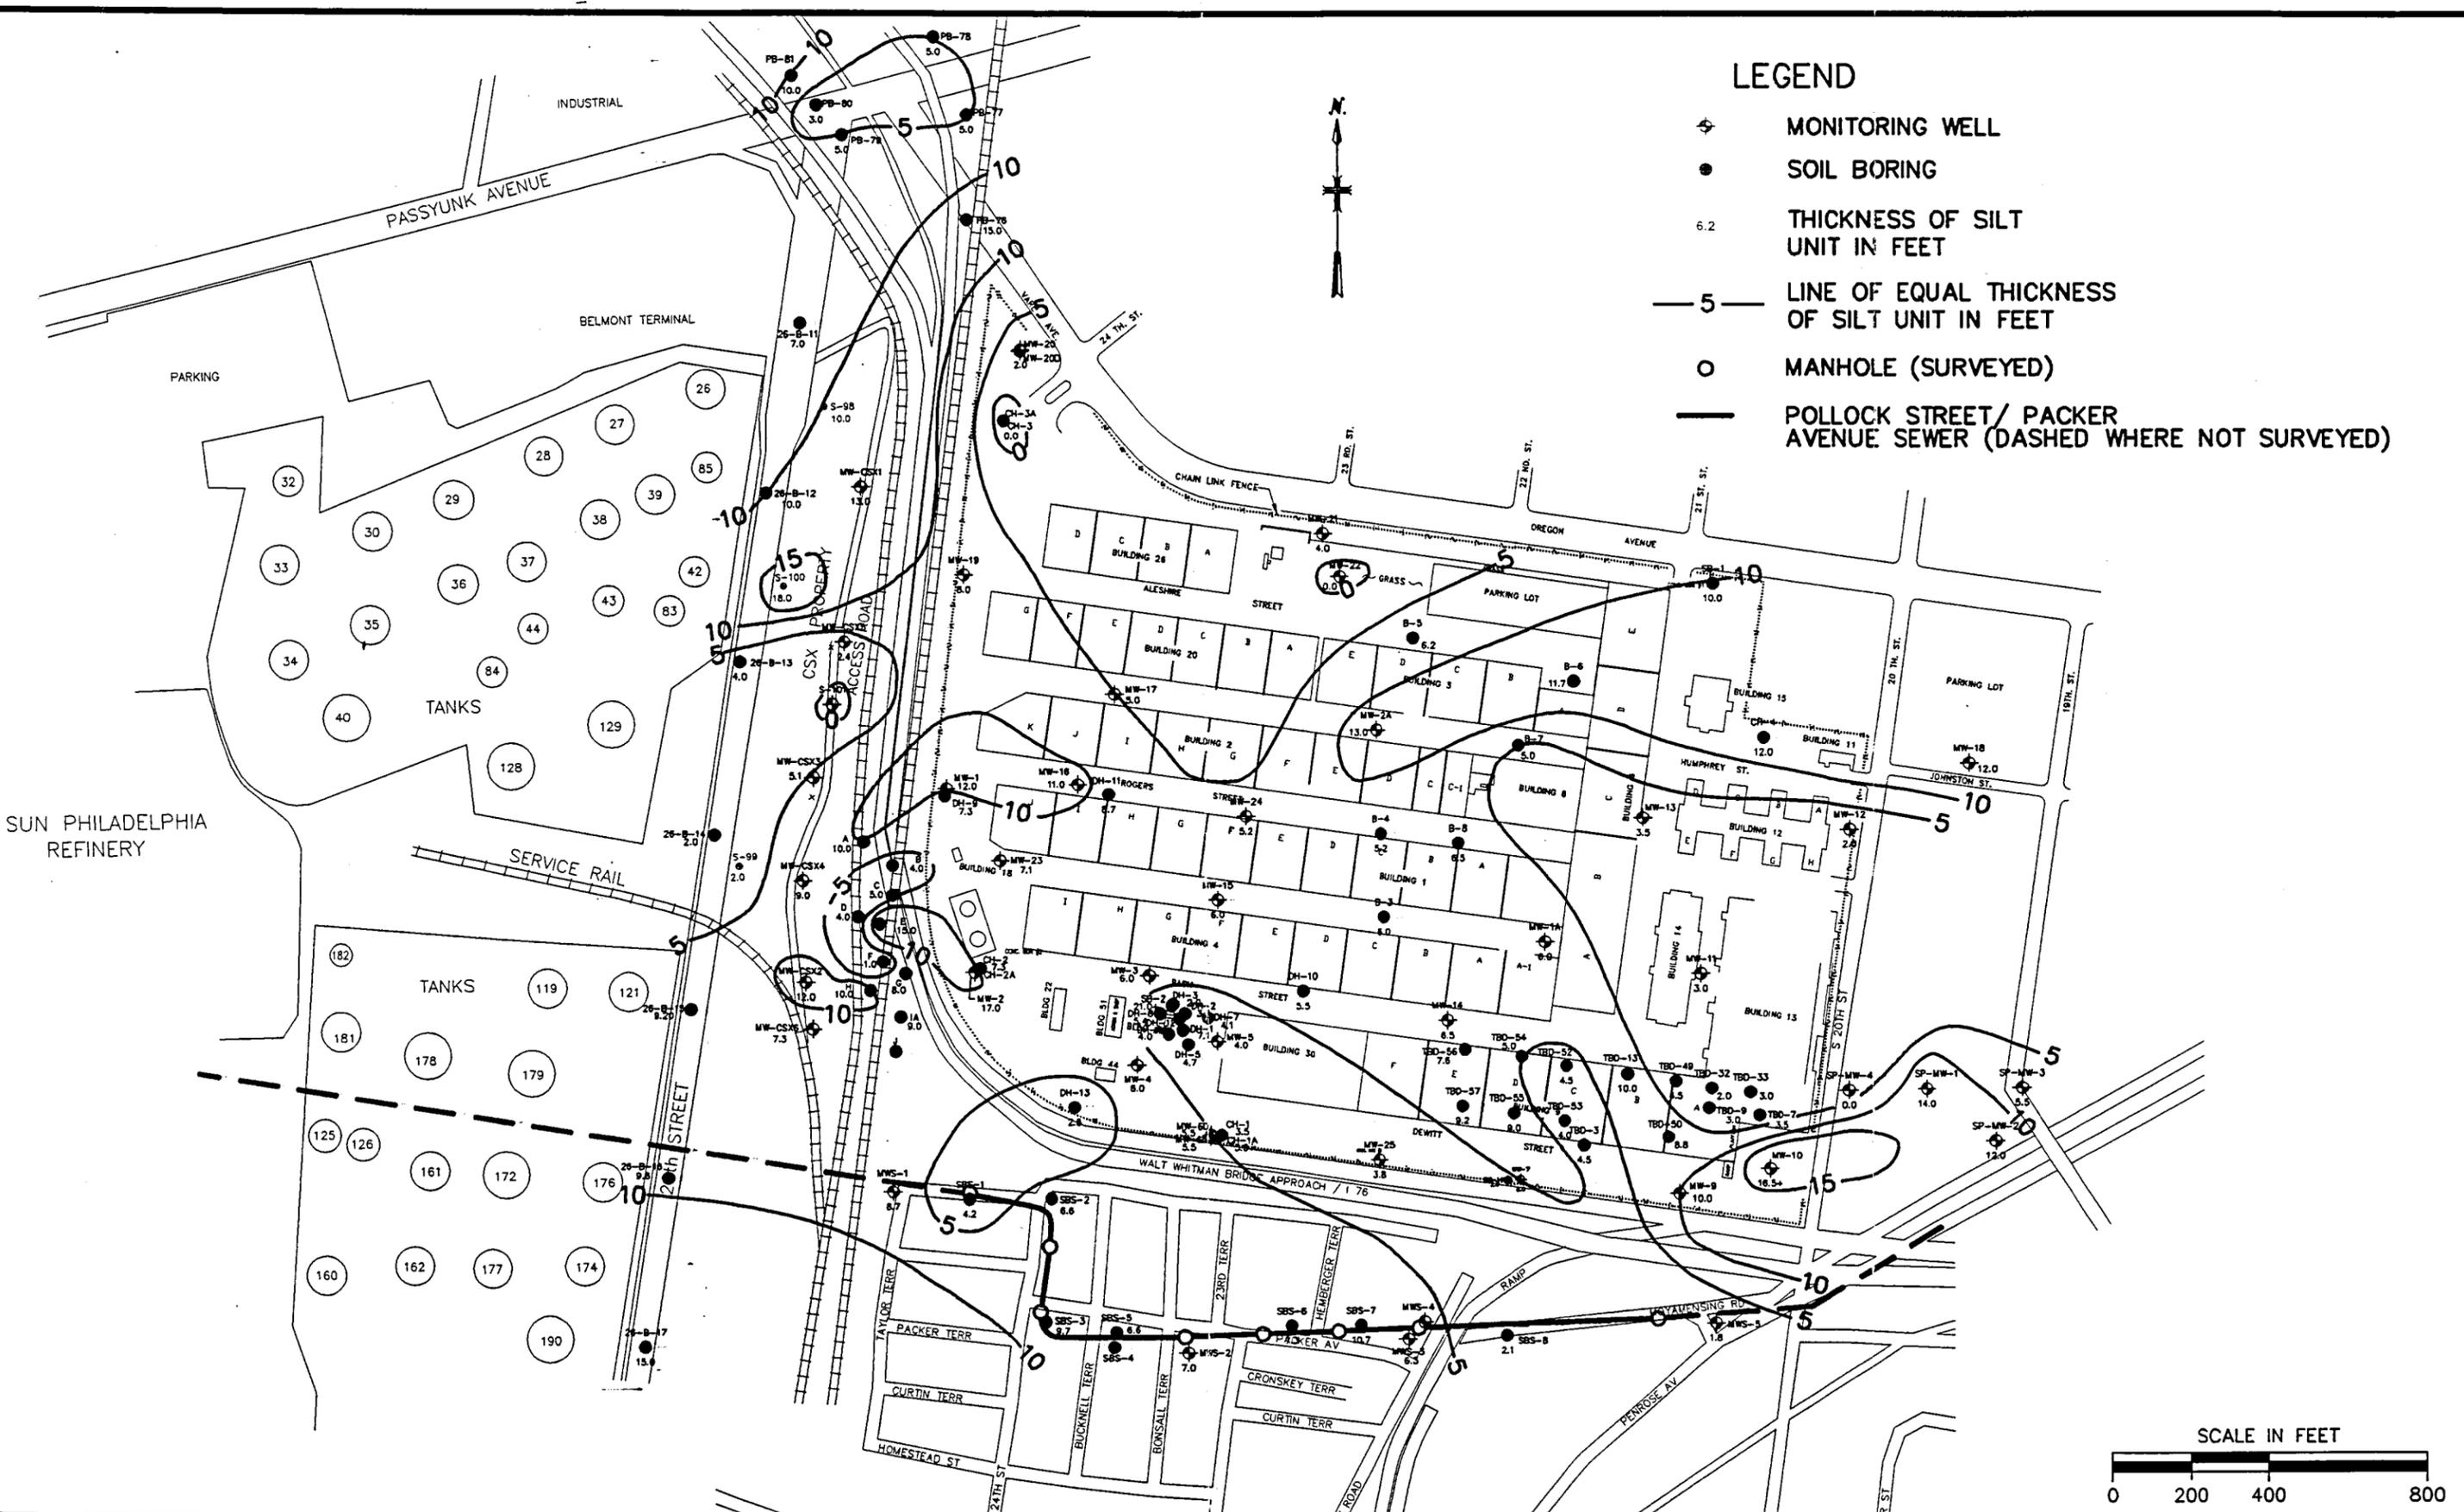
- ⊕ MONITORING WELL
- SOIL BORING
- 6.2 THICKNESS OF SILT UNIT IN FEET
- 5 — LINE OF EQUAL THICKNESS OF SILT UNIT IN FEET
- MANHOLE (SURVEYED)
- POLLOCK STREET/ PACKER AVENUE SEWER (DASHED WHERE NOT SURVEYED)

DEFENSE PERSONNEL SUPPORT CENTER
 USACE CONTRACT NO. DACA31-94-D-0017
 UPPER SILT UNIT ISOPACH CONTOURS

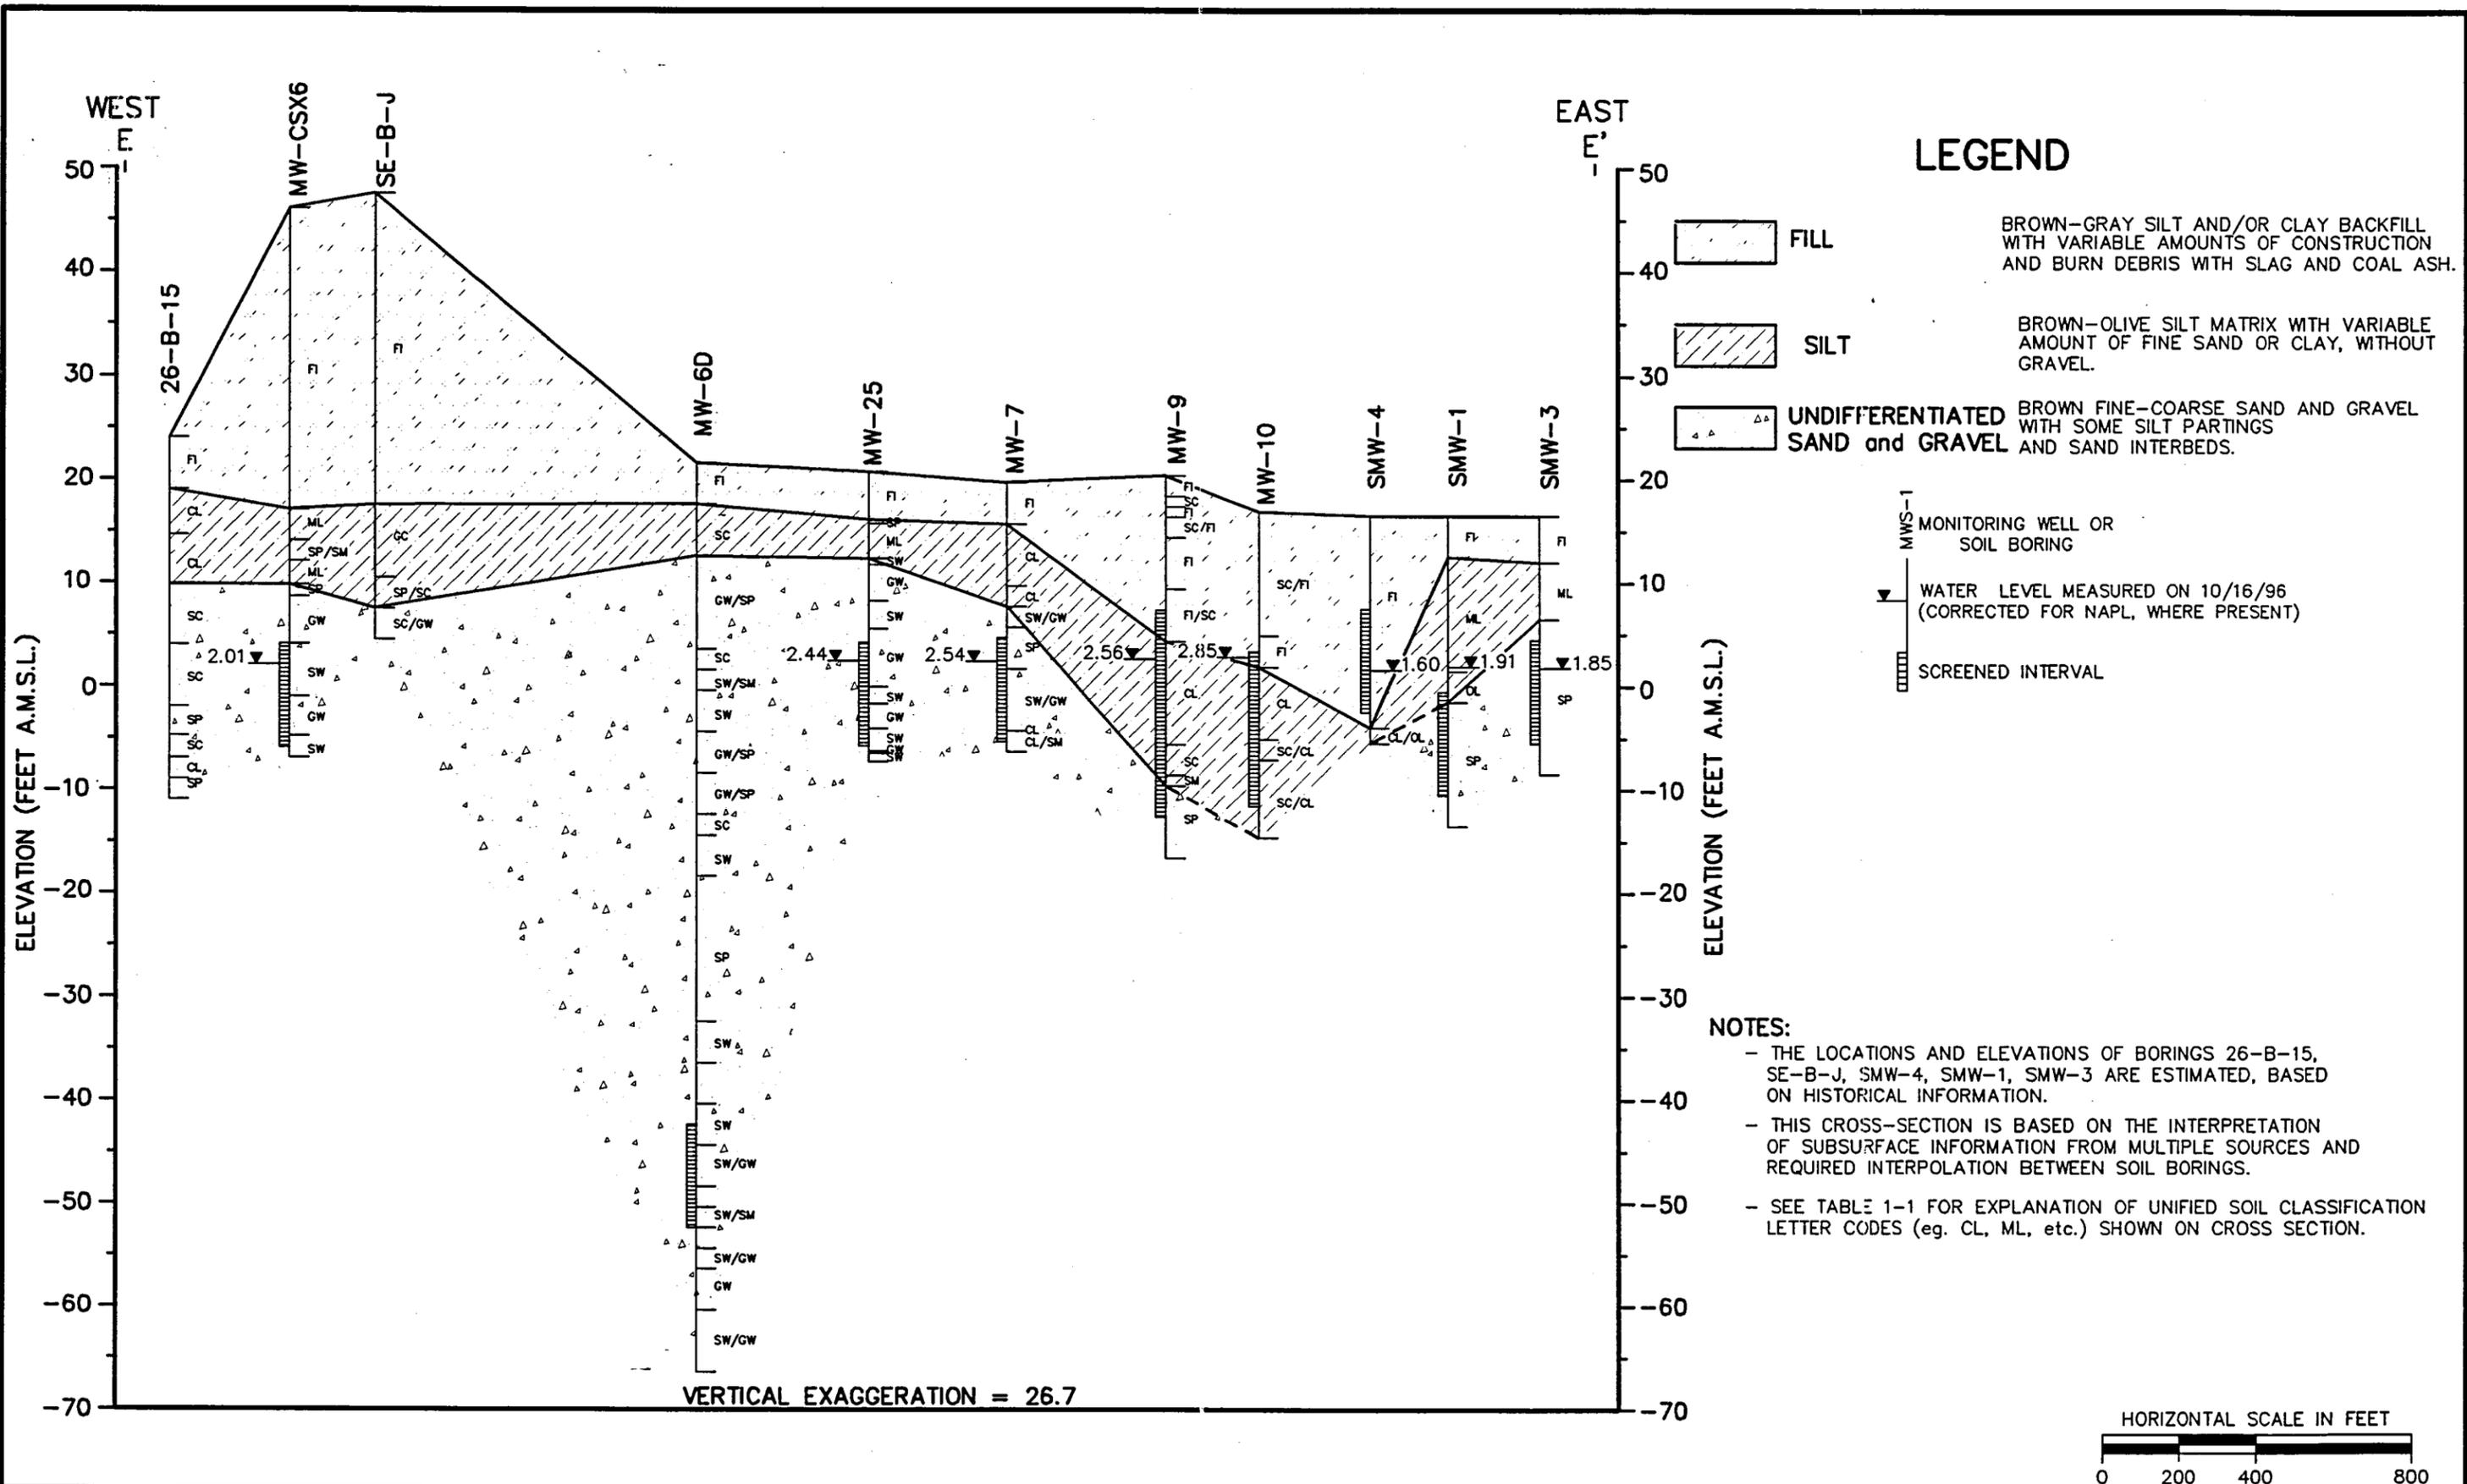
CROSS-SECTION E-E'

FILL
BROWN-GRAY SILT AND/OR CLAY BACKFILL WITH VARIABLE AMOUNTS OF CONSTRUCTION AND BURN DEBRIS WITH SLAG AND COAL ASH.
-

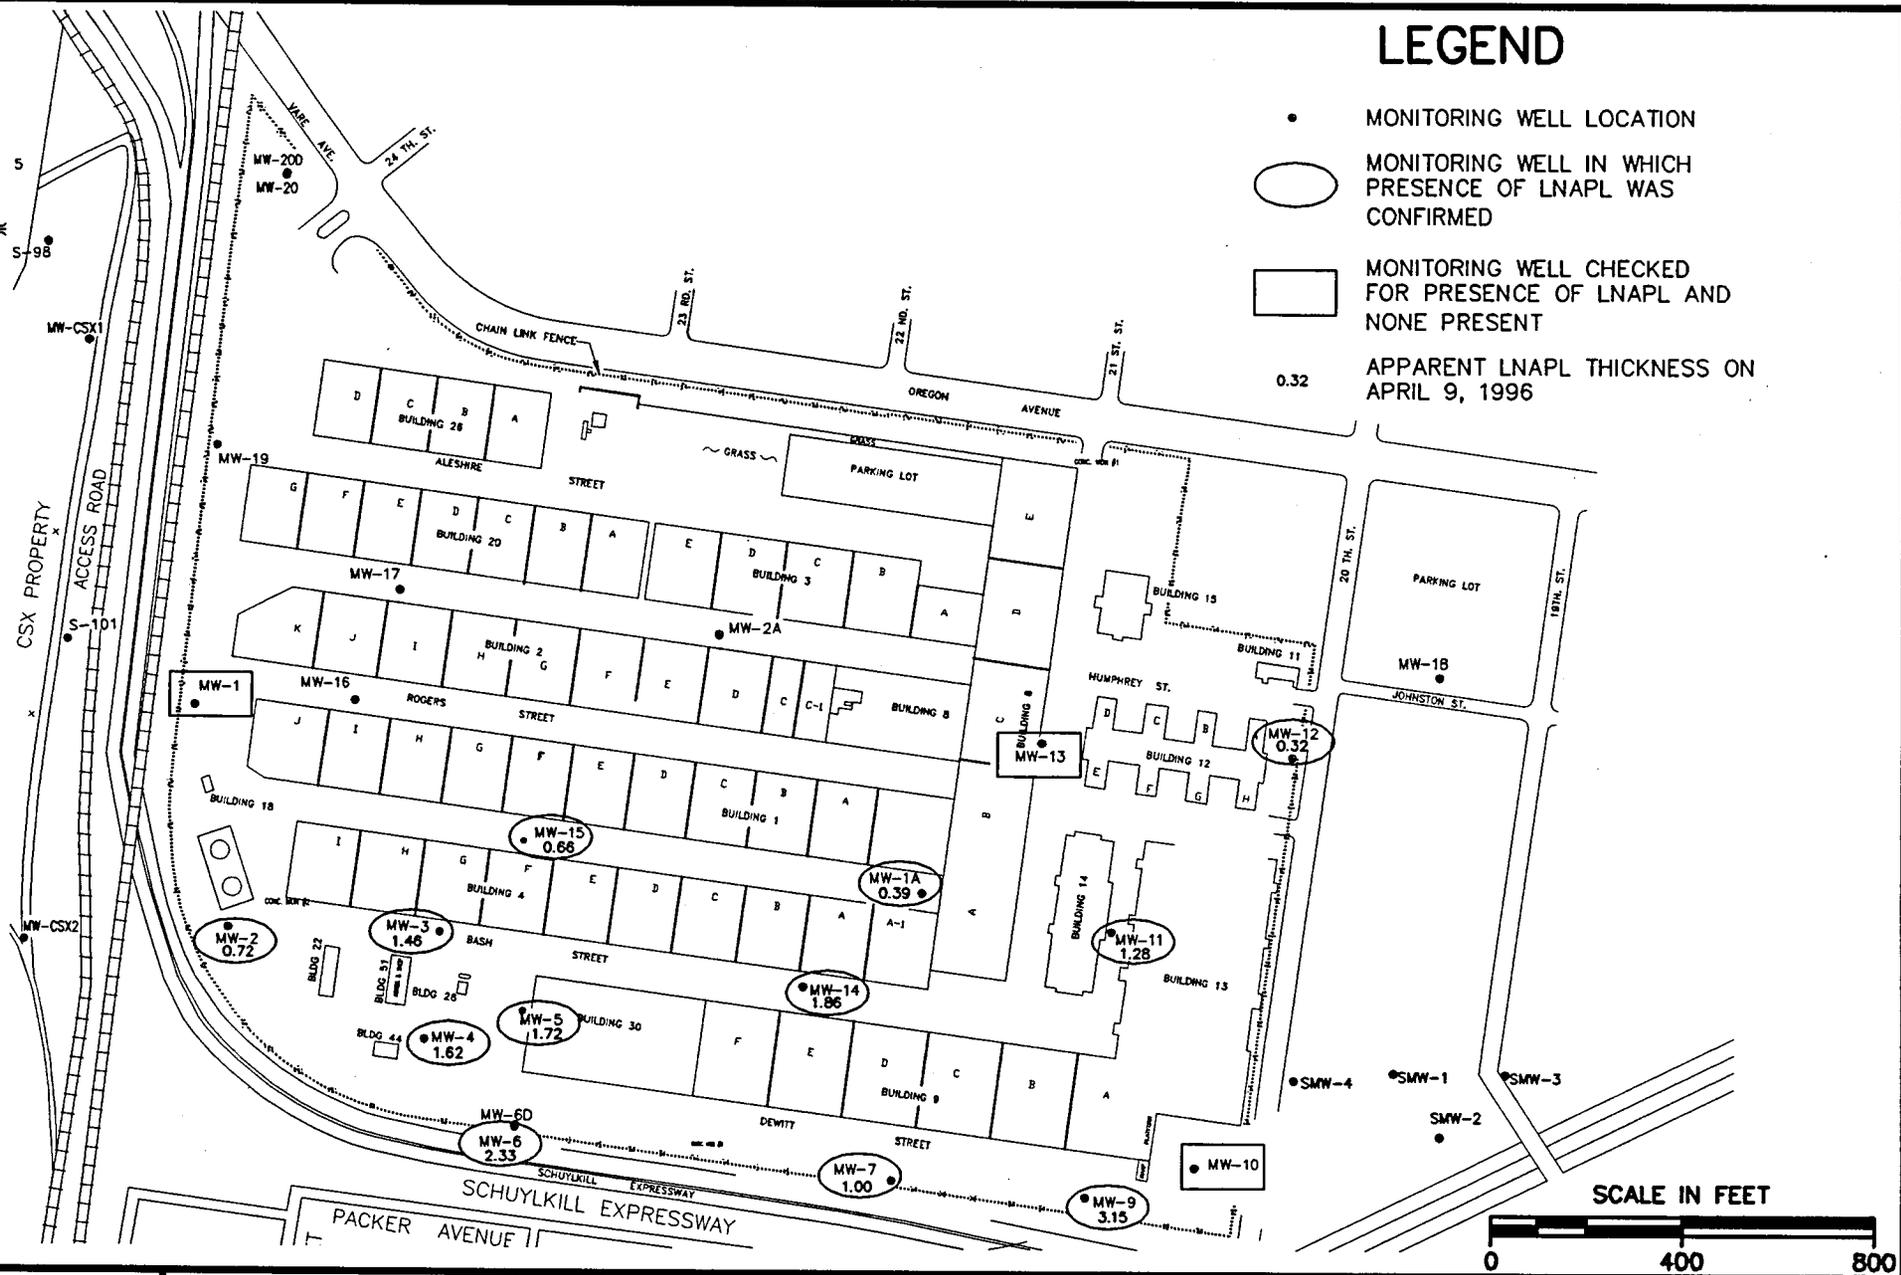
- MONITORING WELL LOCATION
- MONITORING WELL IN WHICH PRESENCE OF LNAPL WAS CONFIRMED
- MONITORING WELL CHECKED FOR PRESENCE OF LNAPL AND NONE PRESENT
- 0.32 APPARENT LNAPL THICKNESS ON APRIL 9, 1996

DEFENSE PERSONNEL SUPPORT CENTER
 USACE CONTRACT NO. DACA31-94-D-0017
NAPL BAILODOWN/RECOVERY TEST LOCATIONS

In general, the field and analytical methods outlined in the Recommendation Letter-Light Non-Aqueous Phase Liquid Baildown/Recovery Testing were employed. Due to the limited thickness of the NAPL and the imprecise nature of bailing, some water was removed during the baildown/recovery tests in all wells with the exception of MW-9 and MW-11. Based on the percentages of NAPL and water removed from tested wells (Table 3-1) and the shapes of the resulting data curves (Appendix E), the analysis method proposed by Gruszczenski (1987) was determined to be the most appropriate and was utilized for all baildown/recovery tests. The data from baildown/recovery tests on some wells from which mostly NAPL was removed were also analyzed using the Hughes et al. (1988) analysis method for comparison. Details of the data analysis utilizing these methods are discussed in Section 4.2.2.

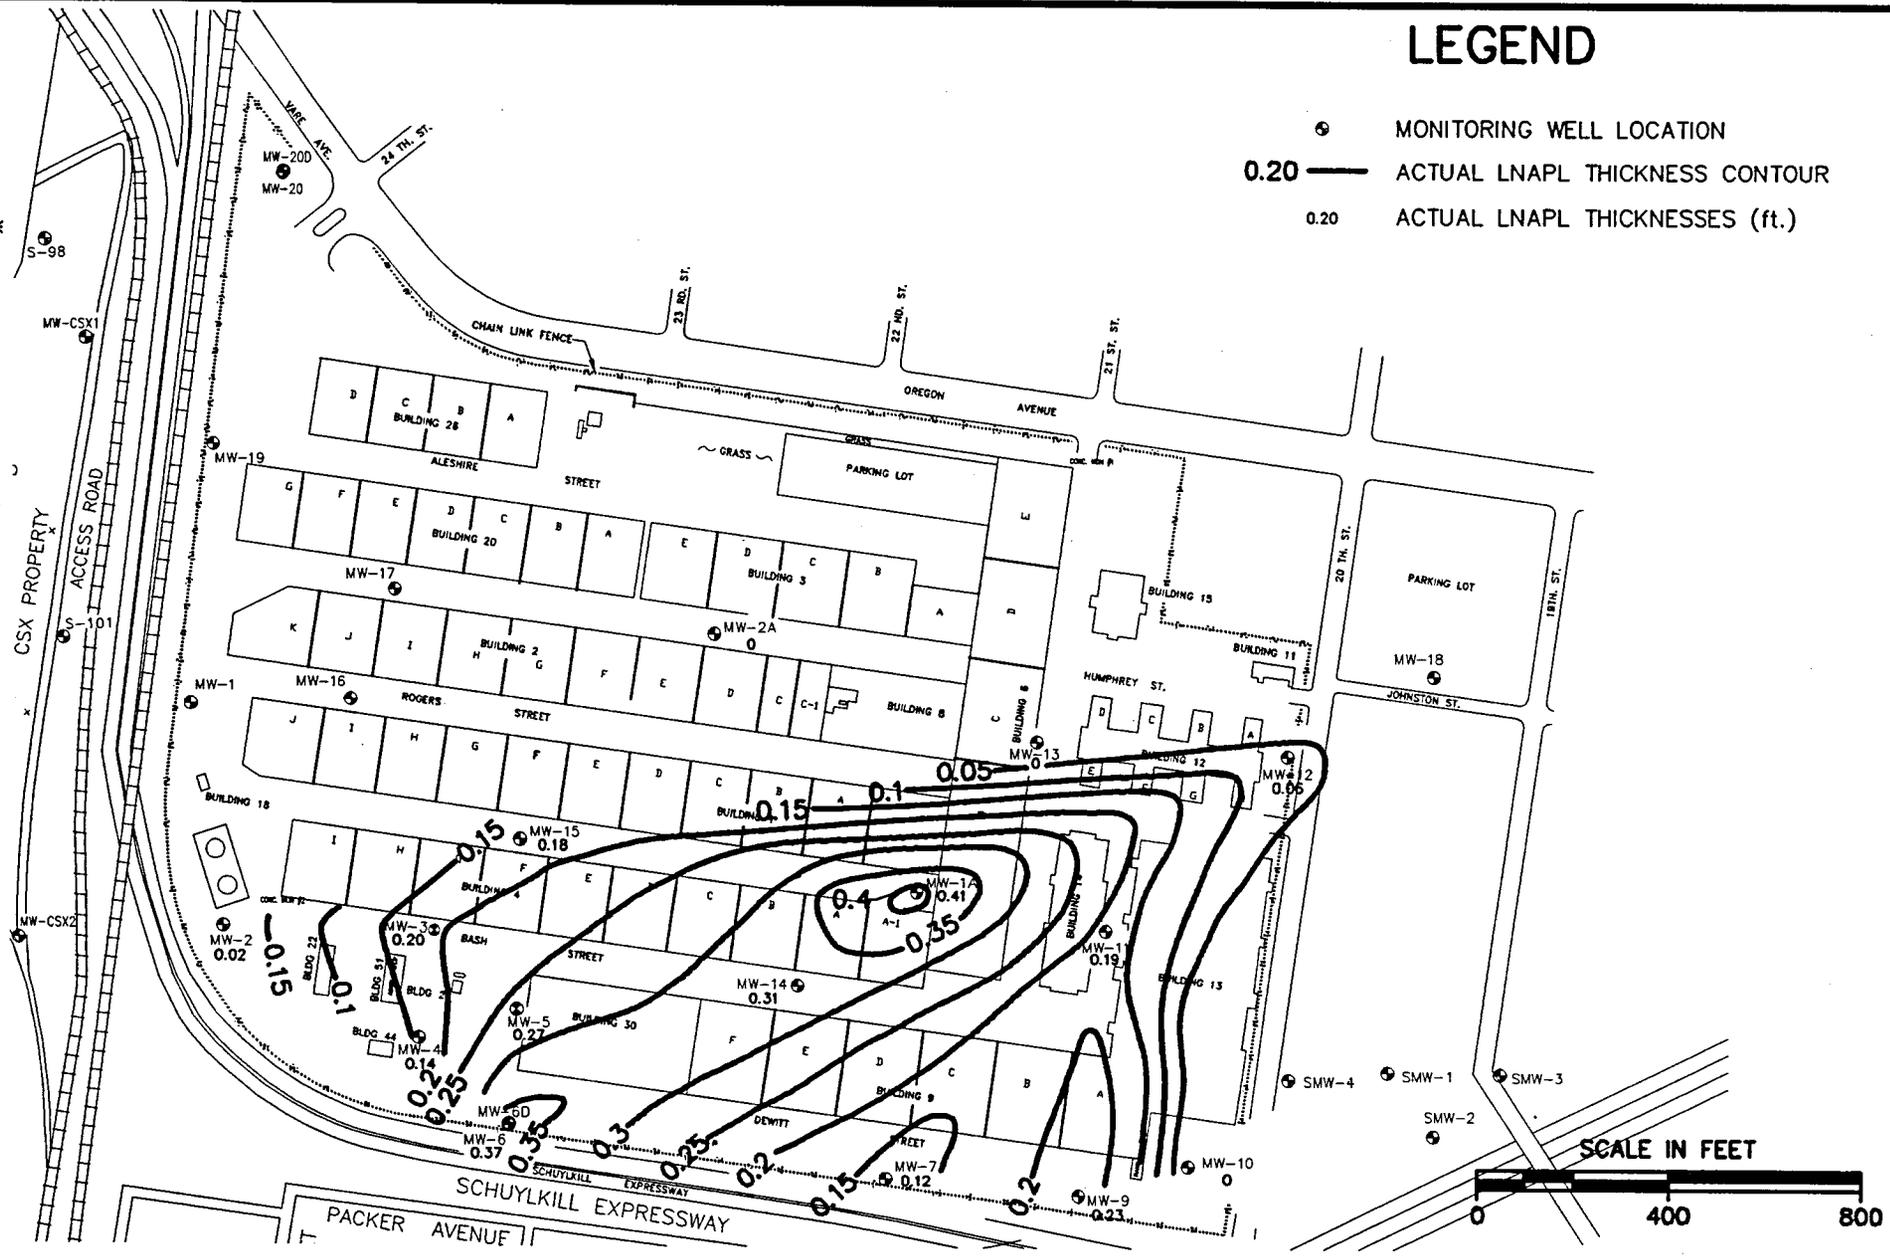
- ⊙ MONITORING WELL LOCATION
- 0.20 — ACTUAL LNAPL THICKNESS CONTOUR
- 0.20 ACTUAL LNAPL THICKNESSES (ft.)

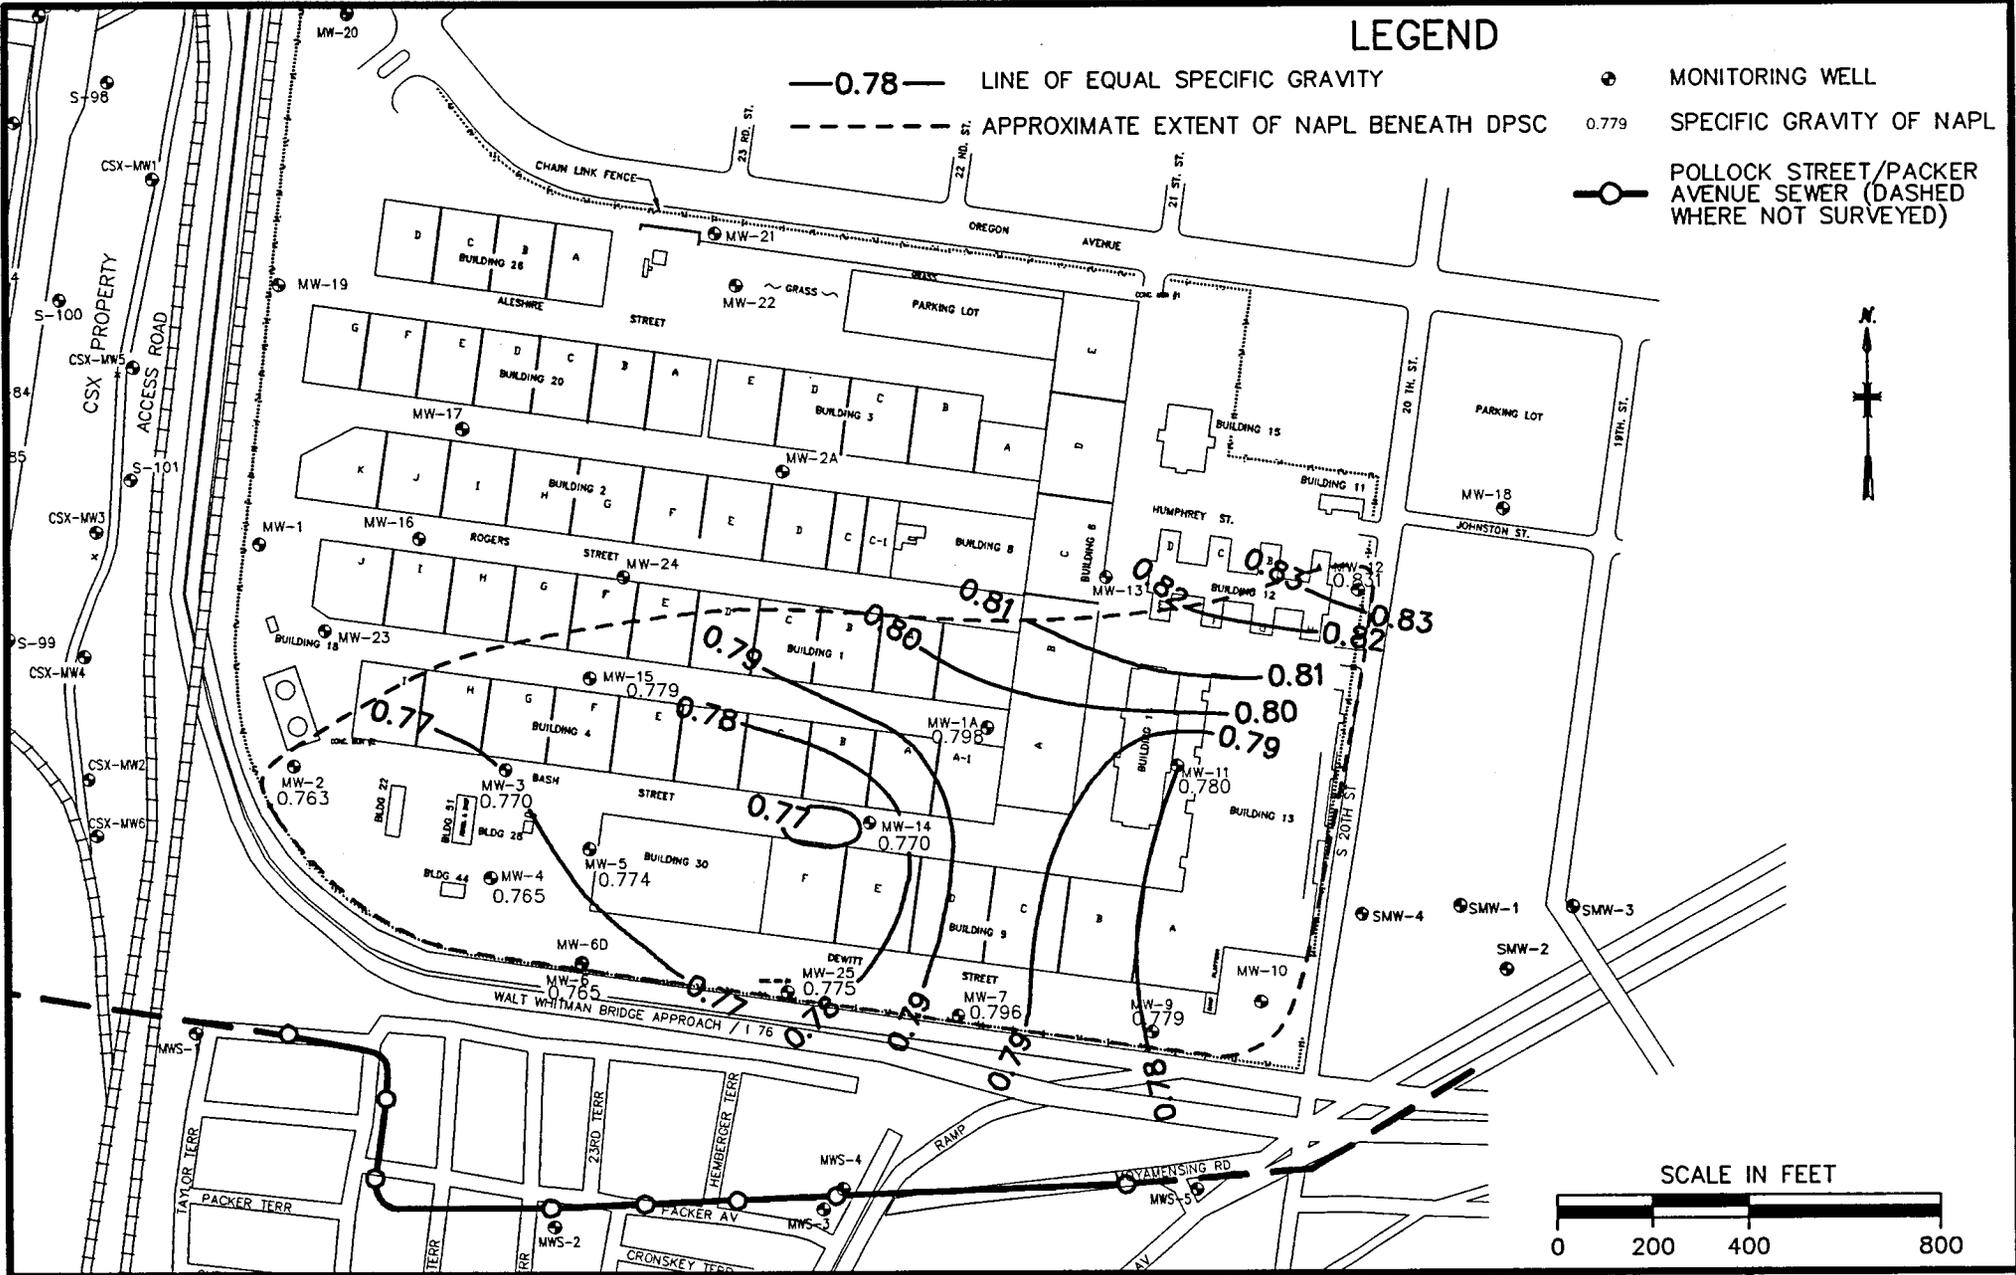
- MONITORING WELL
- 0.779 SPECIFIC GRAVITY OF NAPL
- POLLOCK STREET/PACKER AVENUE SEWER (DASHED WHERE NOT SURVEYED)

DEFENSE PERSONNEL SUPPORT CENTER
 USACE CONTRACT NO. DACA31-94-D-0017
 NAPL SPECIFIC GRAVITY CONTOURS
