NAPL PLUME STUDY

FINAL REPORT

**For
Defense Personnel Support Center
Philadelphia, Pennsylvania**

USACE Contract No. DACA31-94-D-0017

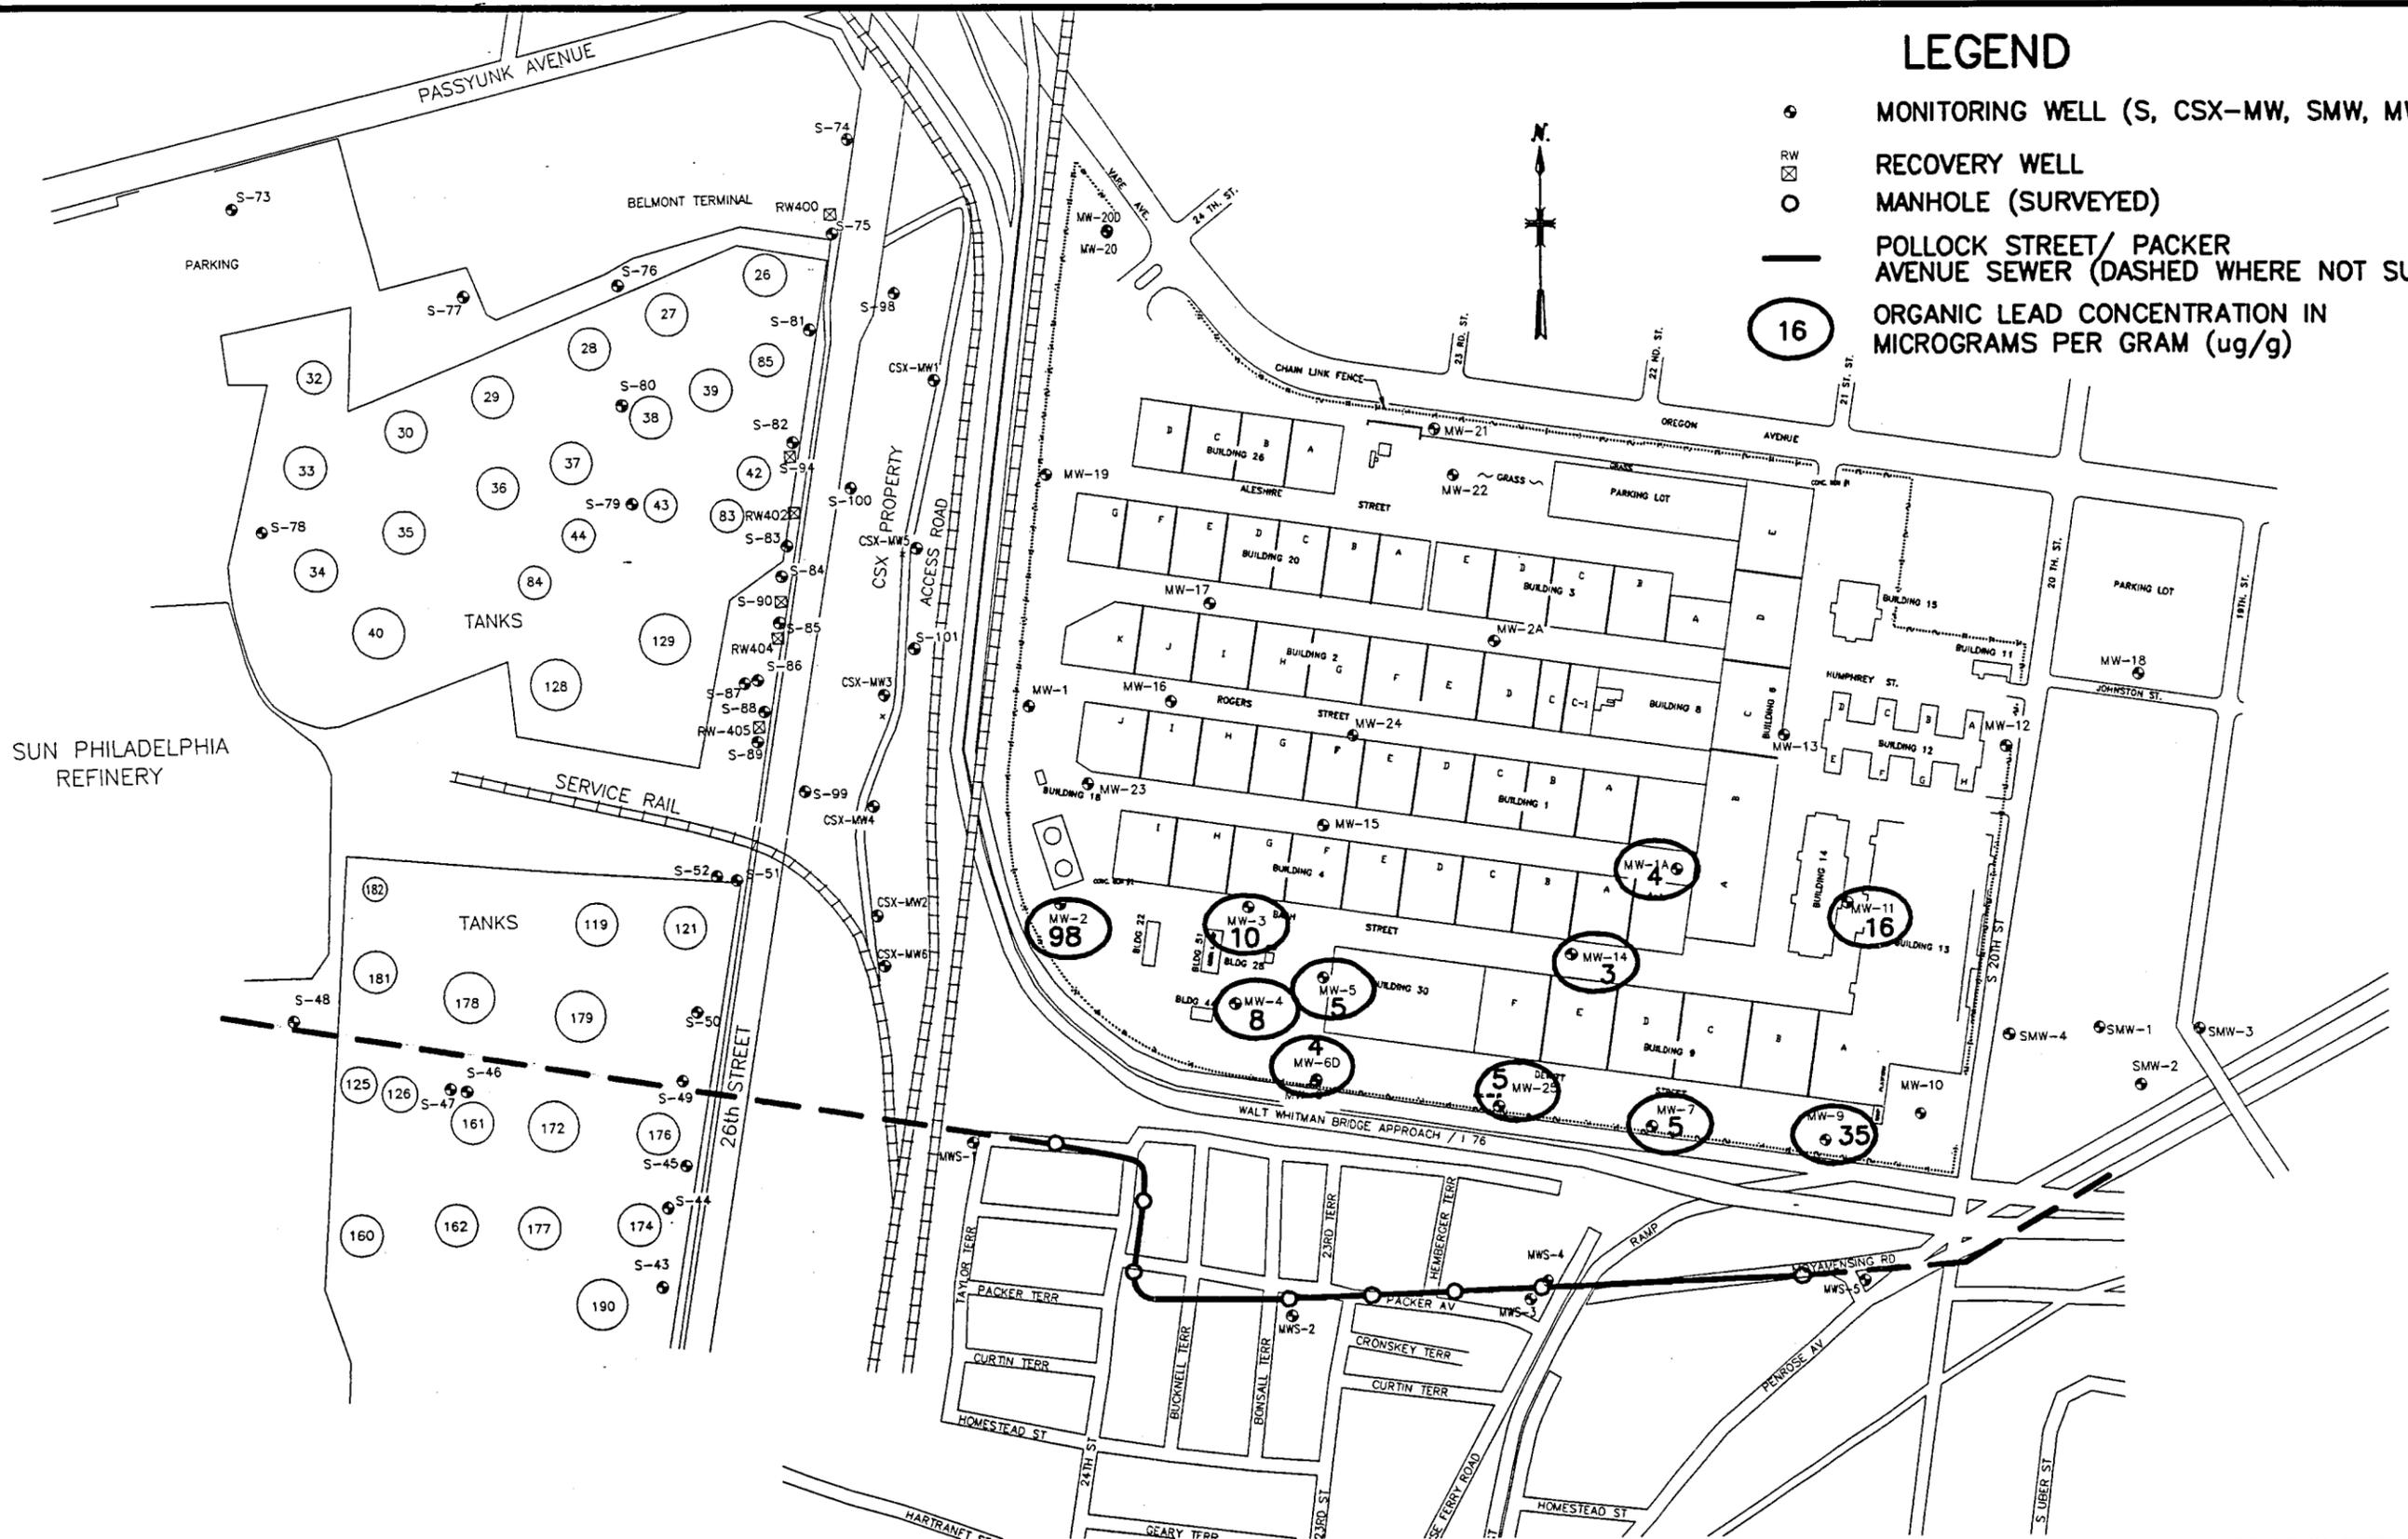
- ⊙ MONITORING WELL (S, CSX-MW, SMW, MWS, MW)
- ⊠ RECOVERY WELL
- MANHOLE (SURVEYED)
- POLLOCK STREET/ PACKER AVENUE SEWER (DASHED WHERE NOT SURVEYED)
- 16 ORGANIC LEAD CONCENTRATION IN MICROGRAMS PER GRAM (ug/g)

DEFENSE PERSONNEL SUPPORT CENTER
 USACE CONTRACT NO. DACA31-94-D-0017
 CONCENTRATION OF ORGANIC LEAD
 IN NAPL SAMPLES

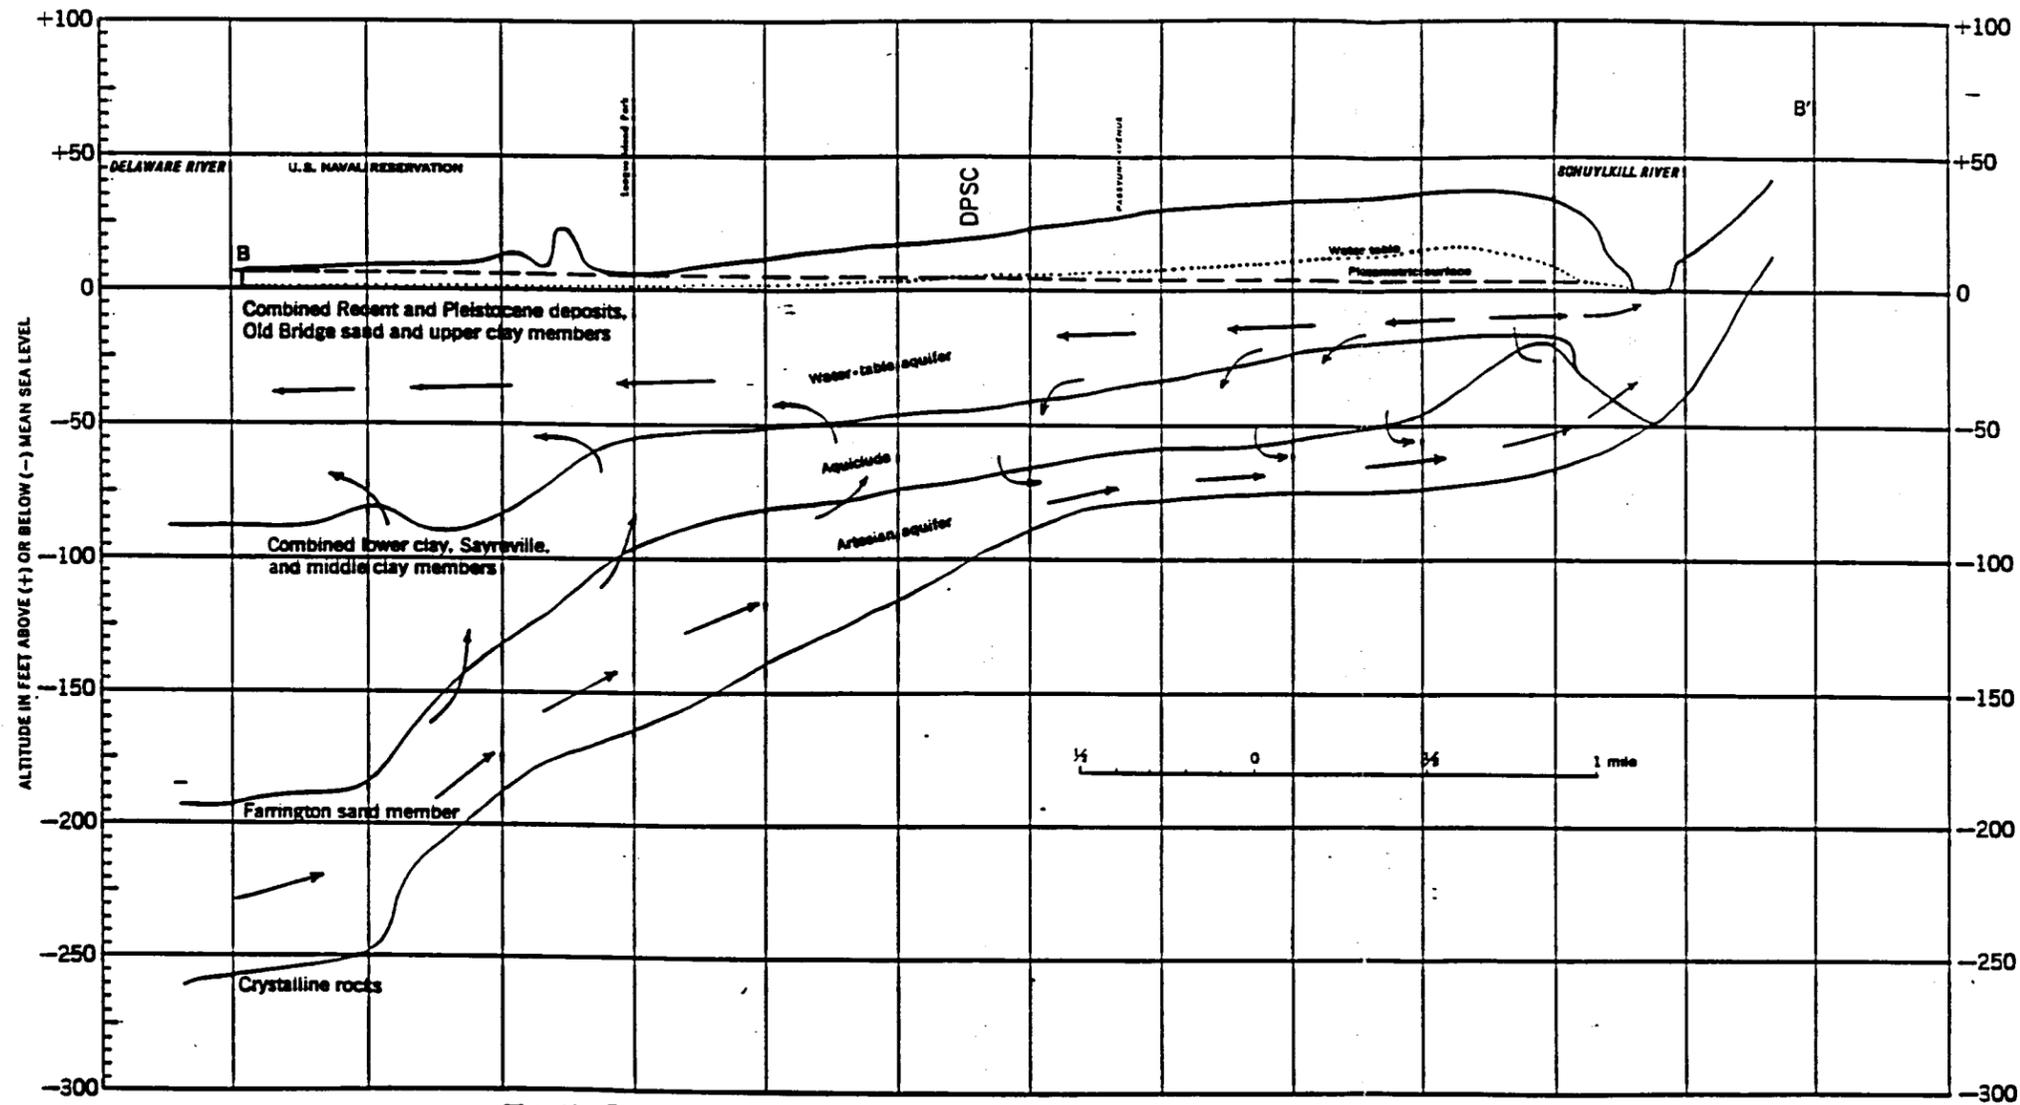
Plate 20 Cross sections showing probable directions of ground water movement in and between aquifers under natural conditions near the junction of the Delaware and Schuylkill Rivers in Pennsylvania.

This general flow direction is supported by water-level data reported for 1932 (Sun, 1997) and from 1982 through 1997. Figure 5-2 shows water levels measured in 1932 during non-pumping conditions. These former monitoring points were located in the southeastern portion of the ARCO/Sun Refinery property. In instances where test holes were dry, the depth below which groundwater is present is indicated with a less than "<" sign. Water levels from a series of four wells in the vicinity of the Pollock Street/Packer Avenue sewer indicate an easterly direction of groundwater flow. As shown in Figure 5-2, Well #17, Well #15, Well #14, and Well #13 are generally arrayed along a west-northwest to east-southeast trend. The

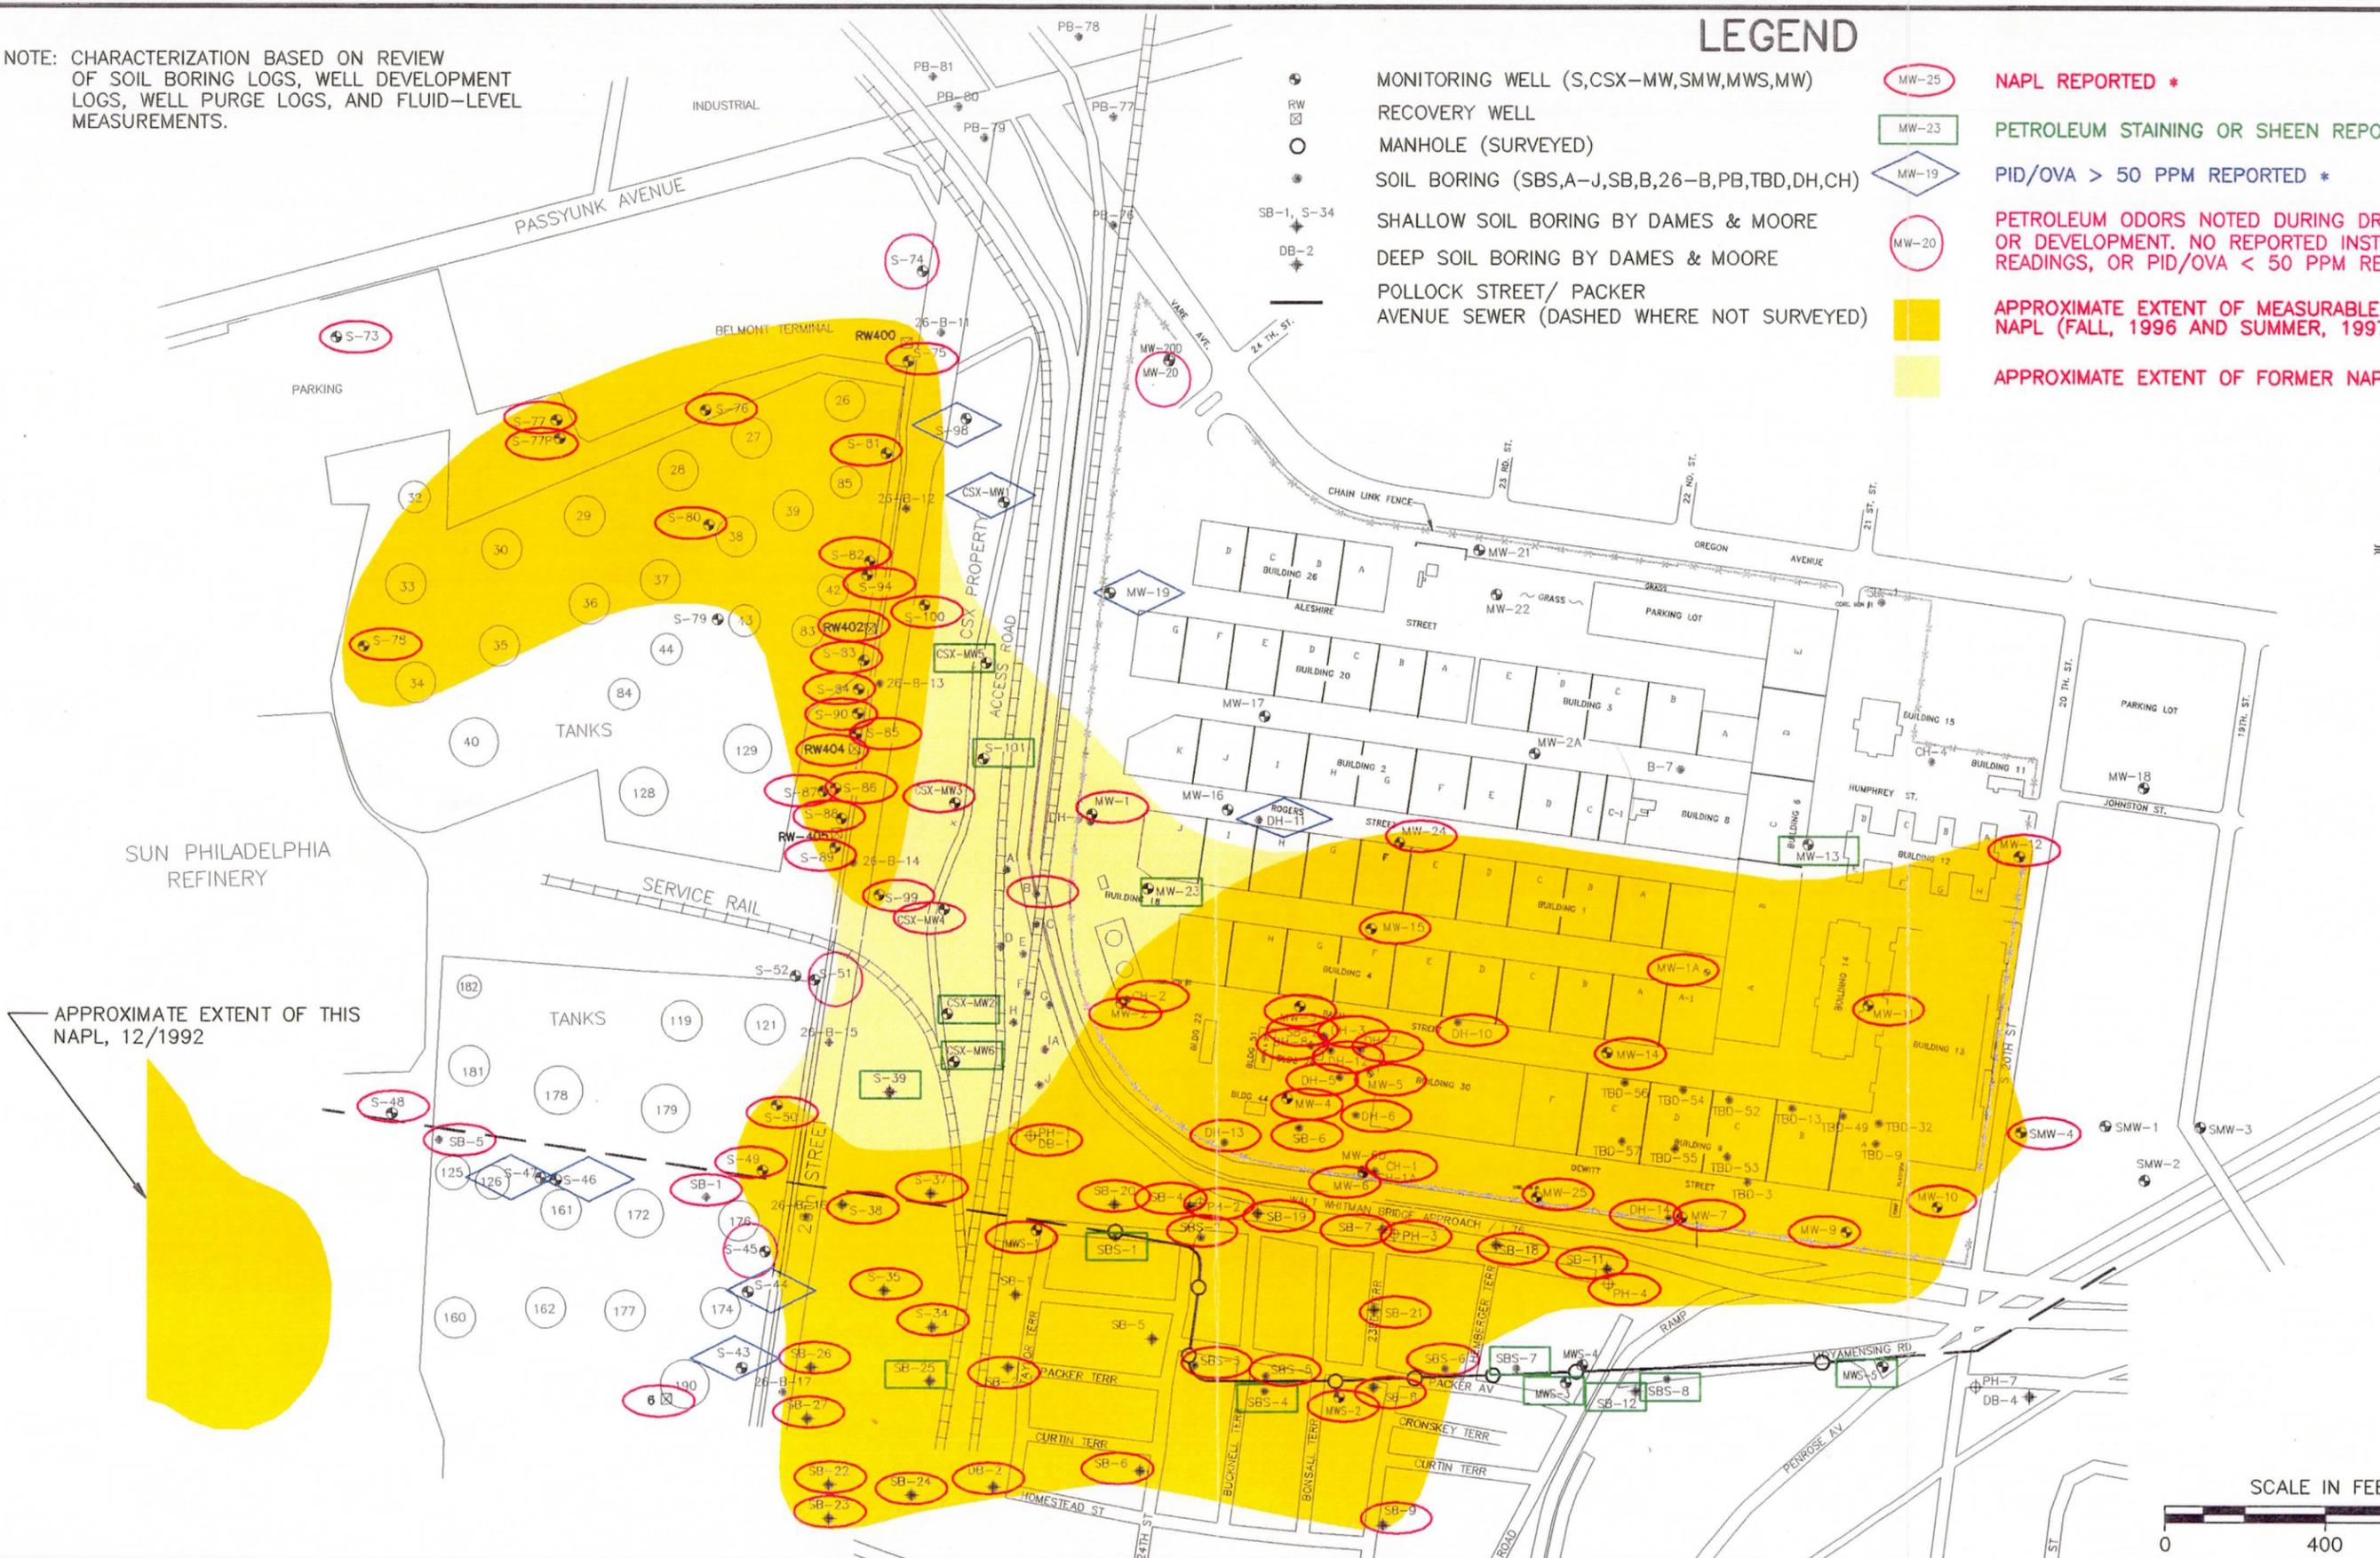
APPROXIMATE EXTENT OF THIS NAPL, 12/1992

Historical records, including soil boring logs, well development logs, well purge logs, and fluid-level measurements were reviewed to identify the presence of NAPL or relict NAPL contamination. This historical evidence was combined with the results of the field activities conducted as part of this study. Figure 5-5 shows the wells and soil borings in which NAPL, petroleum staining or petroleum sheens, or petroleum vapors greater than 50 ppm have been reported. A threshold of 50 ppm for petroleum vapors is a conservative value which should effectively screen out locations which may have been affected by non-NAPL contamination. To further evaluate the potential presence of NAPL or relict NAPL, petroleum odors detected during drilling or well development were noted on Figure 5-5.

As shown in this figure, NAPL has been recorded in a continuum of monitoring wells between the ARCO/Sun Refinery South Yard and the southern portion of DPSC and the Passyunk Homes area. In general, petroleum staining or petroleum sheens were reported in borings or wells along the margins of the area which encompasses NAPL-containing borings and wells. In general, borings and wells in which only petroleum odors were noted or vapors were detected greater than 50 ppm are along the outer margin of borings and wells which contained NAPL, petroleum staining, or petroleum sheens.

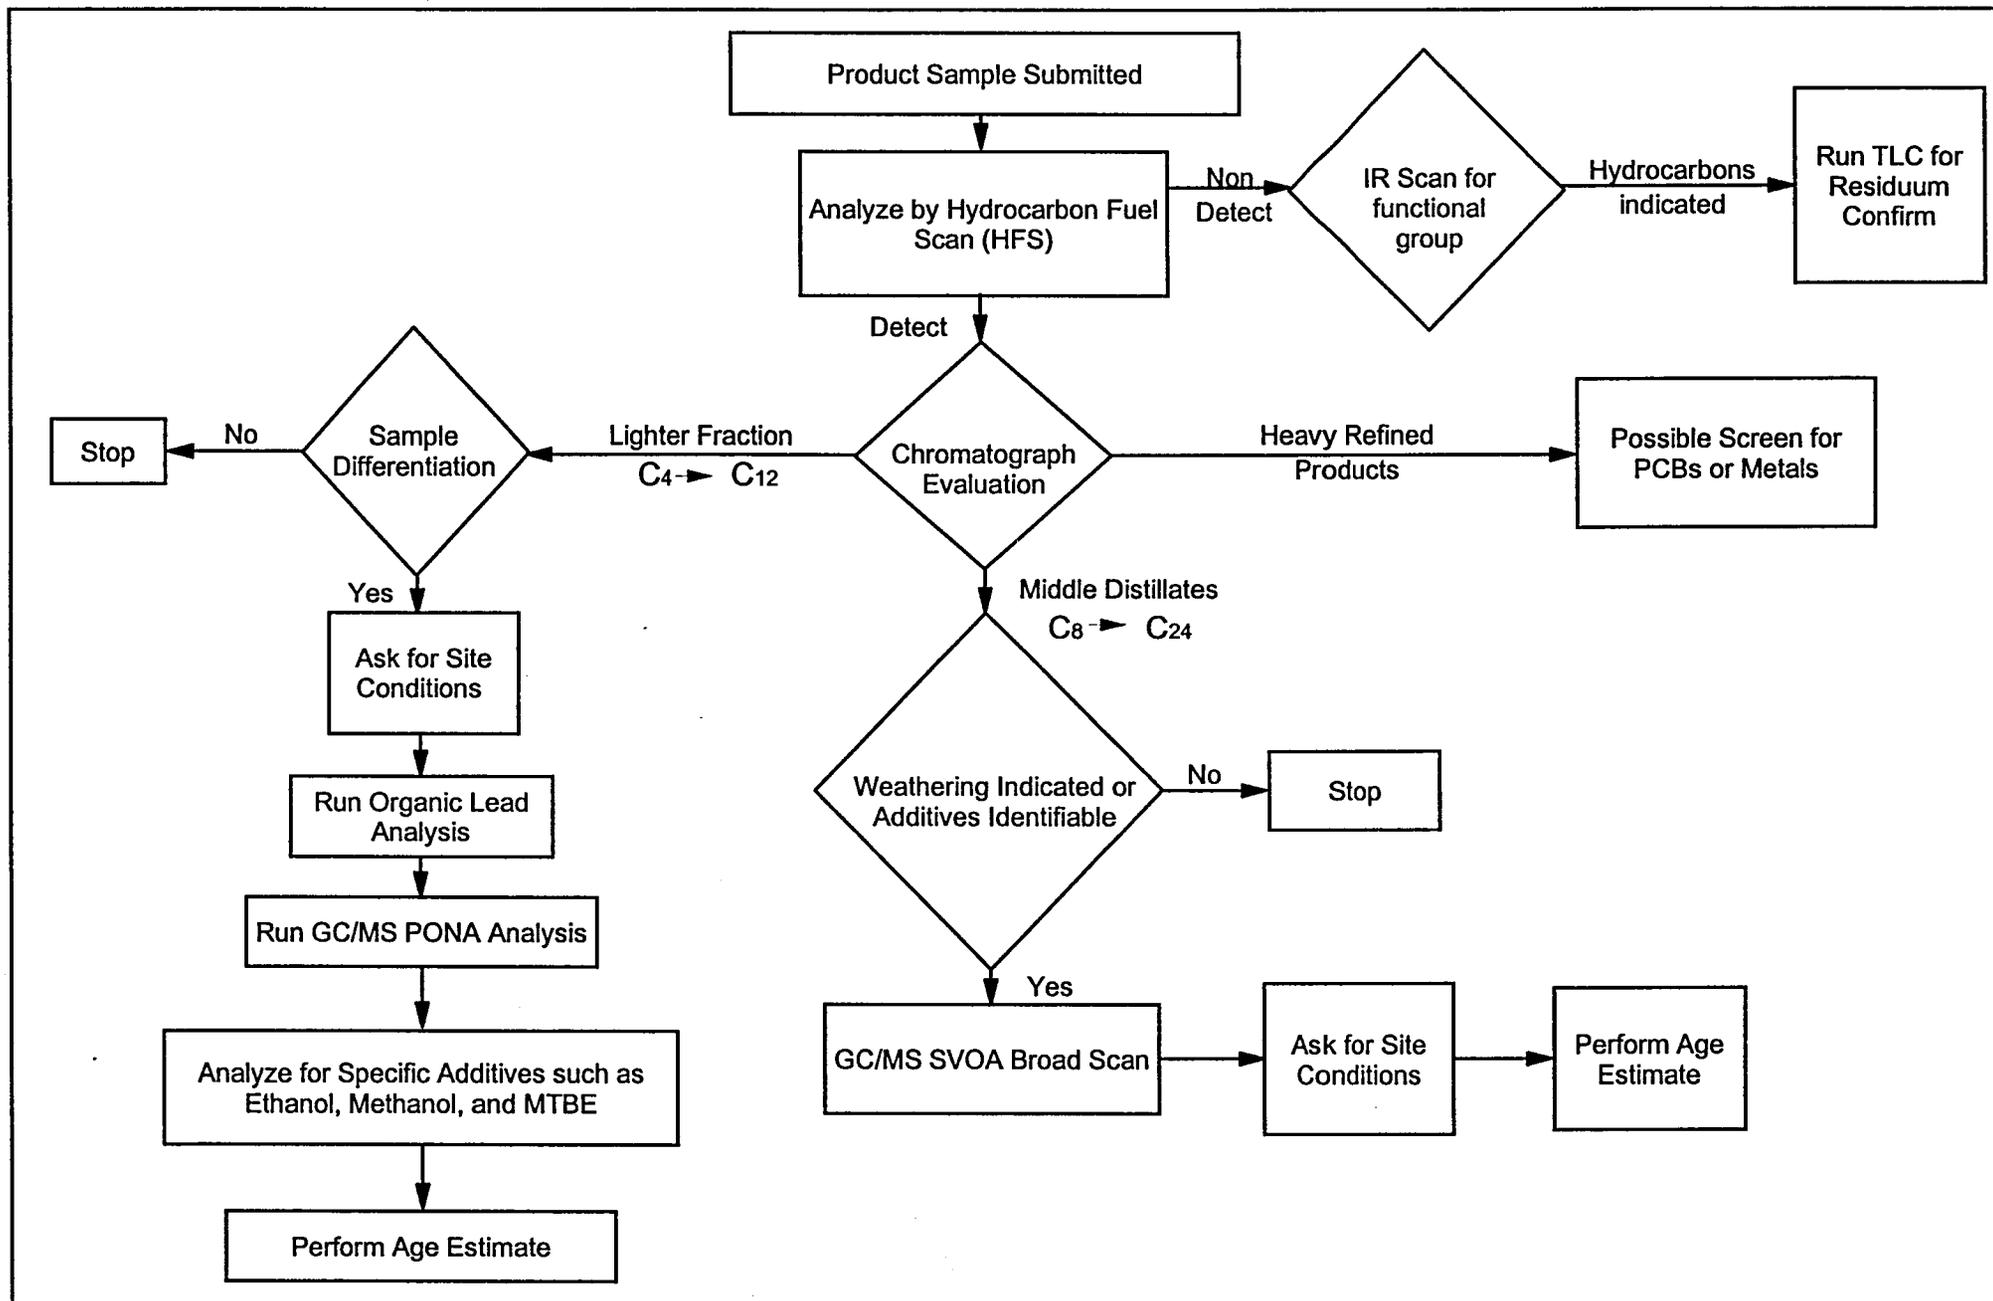
FIGURE L-1
 NAPL PLUME STUDY
 DEFENSE PERSONNEL SUPPORT CENTER
 PHILADELPHIA, PENNSYLVANIA
 MULTI-TIERED ANALYTICAL SEQUENCE

TRPH-IR scan is run. This analysis assists the analyst in assessing the sample and in determining what additional tests may be performed to identify the material. If the presence of hydrocarbons is detected by the TRPH-IR scan, a Thin Layer Chromatography (TLC) for residuum compounds is performed. This analysis detects the presence or absence of compound types such as alkanes, aromatics, and polar compounds.

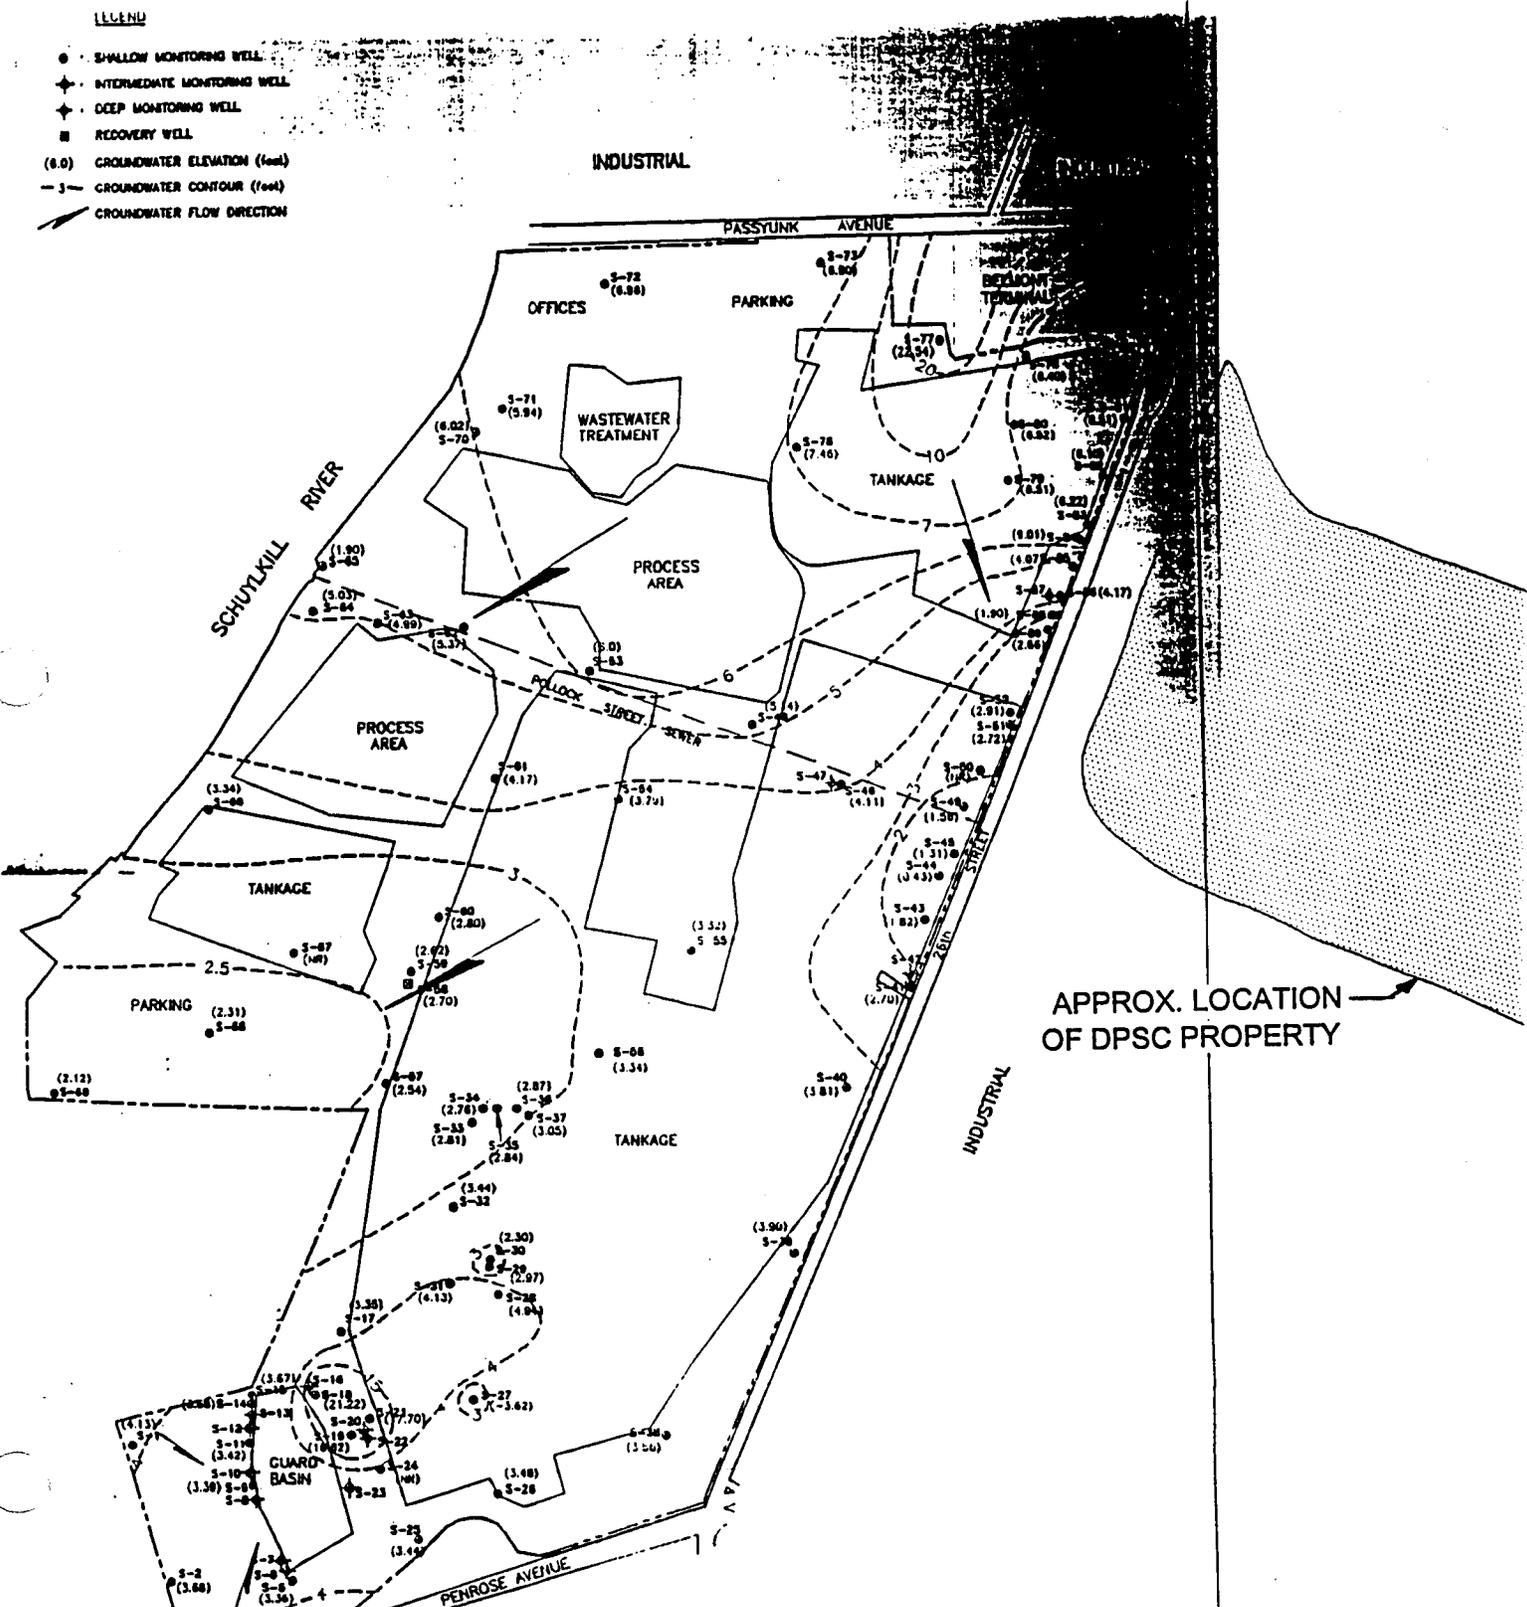
- SHALLOW MONITORING WELL
- ⊕ INTERMEDIATE MONITORING WELL
- ⊕ DEEP MONITORING WELL
- ⊕ RECOVERY WELL
- (8.0) GROUNDWATER ELEVATION (feet)
- - - GROUNDWATER CONTOUR (feet)
- GROUNDWATER FLOW DIRECTION

**INTERPRETINE GROUNDWATER GRADIENT
SHALLOW AQUIFER
26-27 MAY 1993
SUN REFINERY - SOUTH YARD**
