RUST

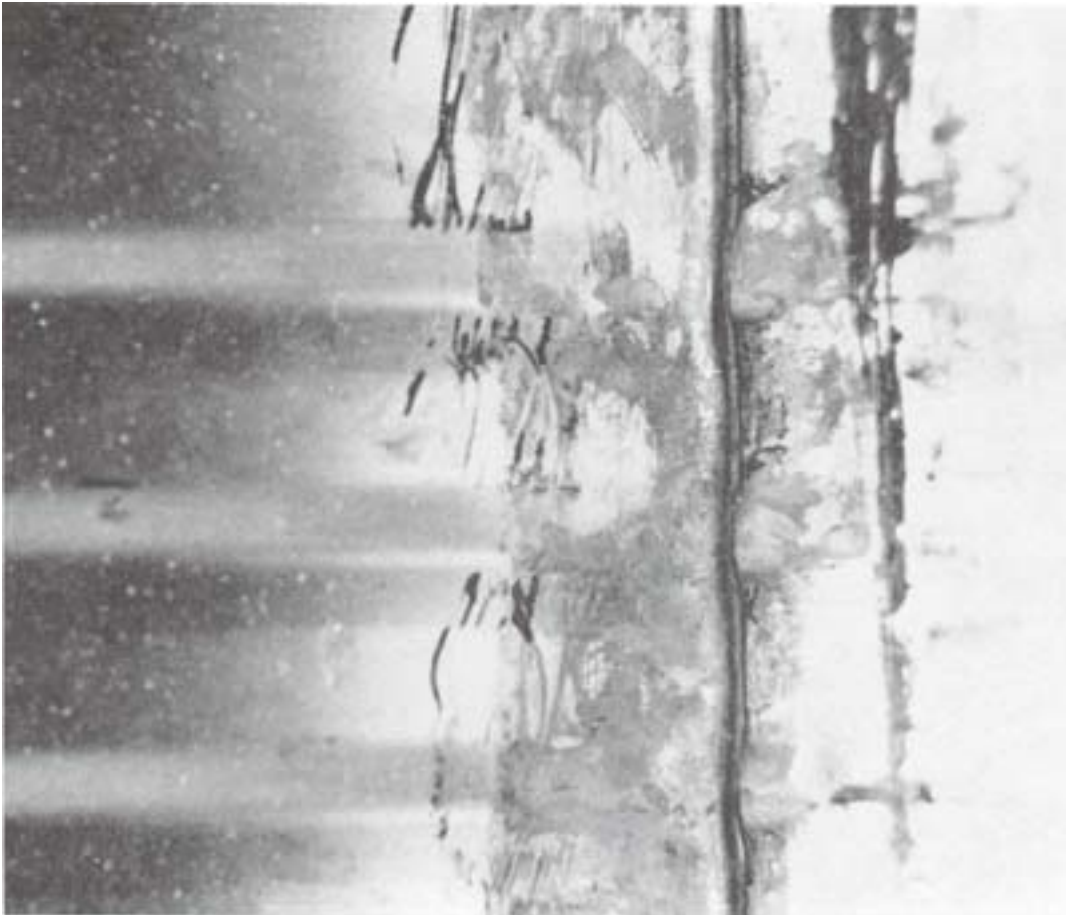
Table IV, Defect No. 109, Major defect. Pitted rust in deep scratches along side seam. The rust undoubtedly developed in the scratches—a related minor defect.
