## DENT

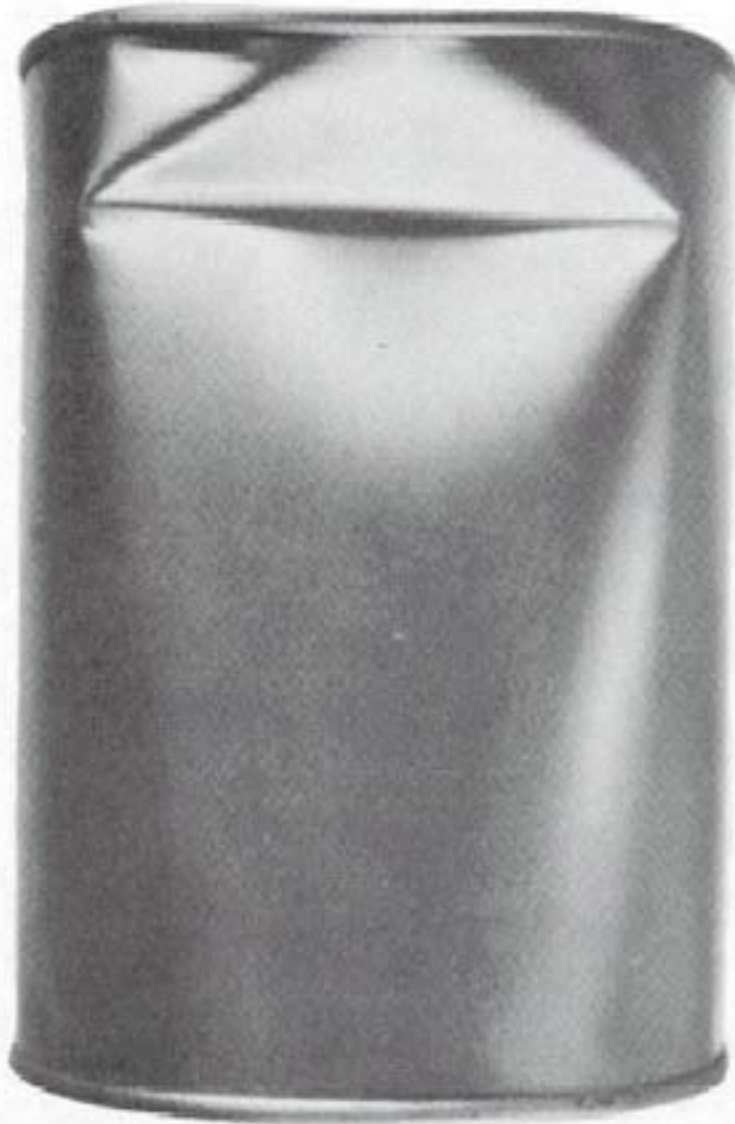
Table IV, Defect No. 208 - Upper limit of a minor defect. A moderately deep, sharp, angular indentation with moderately acute crimping of the body wall (minor defect). End seam malposition is so slight that it could be detected only by use of a straight edge or flat surface (no defect).
