1. TITLE (Class, Function, Type, etc.)		2. DOCUMENT NUMBER
MIL-DTL-22992 Retention Testing		NX4-P-16-08
		3. DATE (DD-MMM-YY)
		11-APR-16
4. MANUFACTURER AND ADDRESS	5. PART NUMBER	6. NATIONAL STOCK NUMBER
Amphenol Aerospace	Not Available	Not Available
40-60 Delaware Ave	7. SPECIFICATION	8. GOVERNMENT PART NUMBER
Sidney, NY 13838	MIL-DTL-22992	MS1734X
	9. LOT DATE CODE START	10. LOT DATE CODE END
	1105	1402
11. MANUFACTURER'S POINT OF CONTACT	12. CAGE	13. MANUFACTURER'S FAX
Ron Williams	77820	Not Available
14. MFR. POC PHONE	15. MANUFACTURER'S E-MAIL	
(607) 563-5344	rwilliams@aao-amphenol.com	
16. SUPPLIER - Not Applicable	17. SUPPLIER ADDRESS - Not Applicable	18. SUPPLIER CAGE - Not Applicable

19. PROBLEM DESCRIPTION / DISCUSSION / EFFECT  
 Amphenol Aerospace (AAO) is currently delinquent on MIL-DTL-22992 group C periodic retention testing.

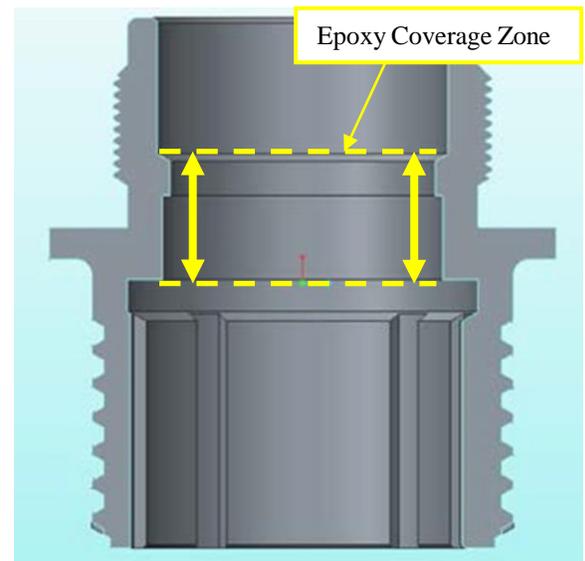
Amphenol has implemented a 100% lot check for this condition. This would include performing a cold soak at -55C for a minimum of 7 hours, bringing the part to room temp, performing an axial load of 30lbs and then returning parts to -50C for at least 30 minutes. After this parts are checked within 30 seconds of coming out of the cold chamber.

Based on DPA it was determined that there was a bond failure between the shell of the connector and the rubber insert. This failure caused an air leak between the shell and the insert after thermal conditioning of -55C for 30 minutes which is performed after temperature cycling and contact retention testing in group 1. The leak requirement is 1 cubic inch/hour at 30 PSI.
