OUTSIDE TINPLATE OR COATING (WHEN REQUIRED)

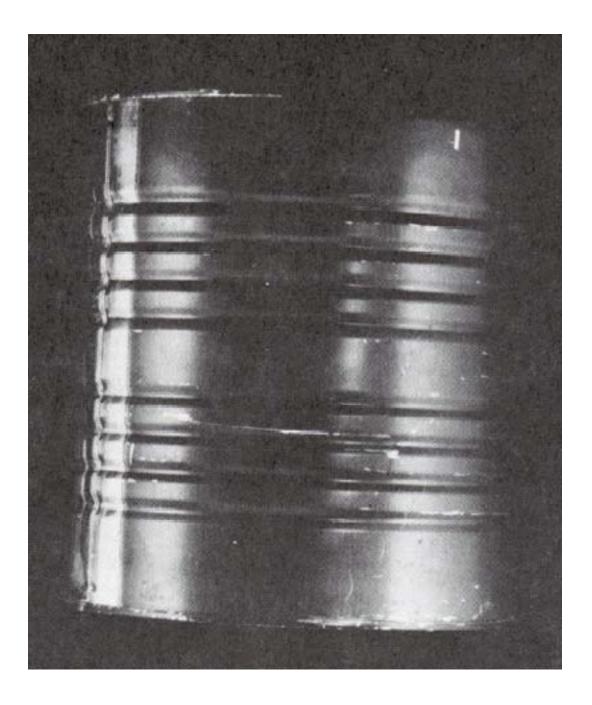
Table IV, Defect No. 204, Minor defect. Outside coating scratched.
